## CONDITION REPORT

Report No: 2016866417

| Manufacturer | MAZDA | Registration Number | HGL017L |
| Model | CX-3 2.0 ACTIVE [2018-2021] | Register Number | |

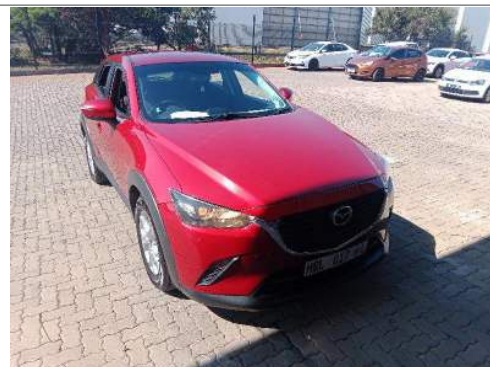
FRONT RIGHT CORNER

| Damage | Repair Way |
|---|---|
| Door Front Right Paintwork • Scratched | Repair |

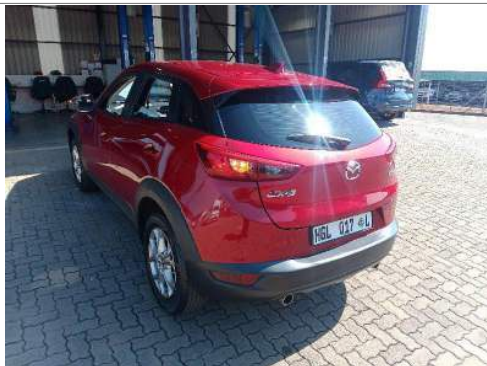
REAR LEFT CORNER

| Damage | Repair Way |
|---|---|
| Rear Fender Left Paintwork • Scratched | Repair |
| Door Rear Left Paintwork • Scratched | Repair |

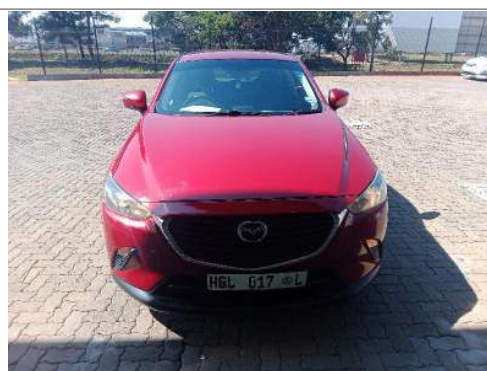
90 DEGREE FRONT

| Damage | Repair Way |
|---|---|
| Front Bumper Paintwork • Scratched | Repair |
| Bonnet Paintwork • Scratched | Repair |

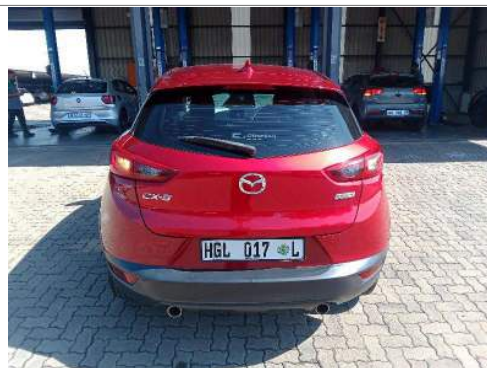
90 DEGREE REAR

| Damage | Repair Way |
|---|---|
| Boot Lid / Hatch door Paintwork • Scratched | Repair |
| Rear bumper Paintwork • Scratched | Repair |

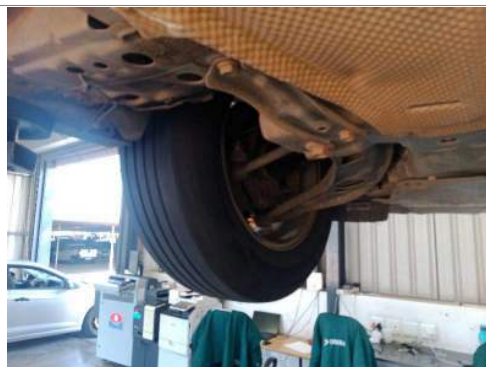
LF TYRE TREAD

| | Size | Load/Speed Index | Manufacture | Model | Type* | Production Date | Tread Depth (mm) |
|---|---|---|---|---|---|---|---|
| Front Left | 215/65R16 | 98H | Royal black | Royal mile | V | 1124 | 4 mm |

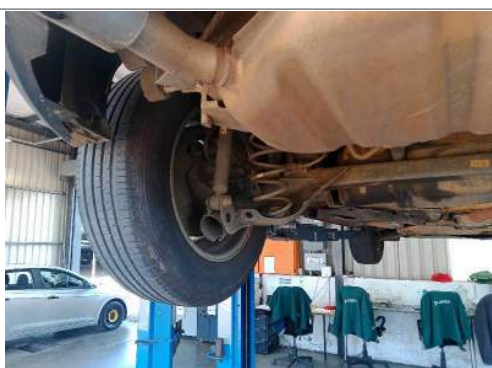
LR TYRE TREAD

| | Size | Load/Speed Index | Manufacture | Model | Type* | Production Date | Tread Depth (mm) |
|---|---|---|---|---|---|---|---|
| Rear Left | 215/65R16 | 98H | Royal black | Royal mile | V | 1124 | 4 mm |

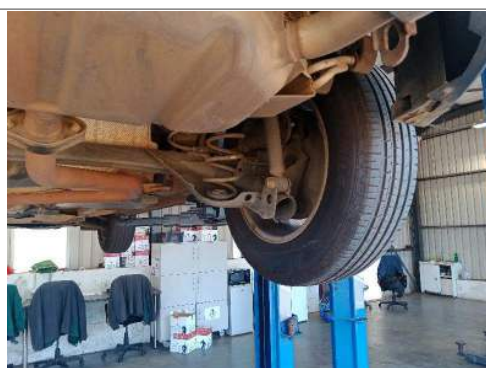
RR TYRE TREAD

| | Size | Load/Speed Index | Manufacture | Model | Type* | Production Date | Tread Depth (mm) |
|---|---|---|---|---|---|---|---|
| Rear Right | 215/65R16 | 98H | Royal black | Royal mile | V | 1124 | 4 mm |

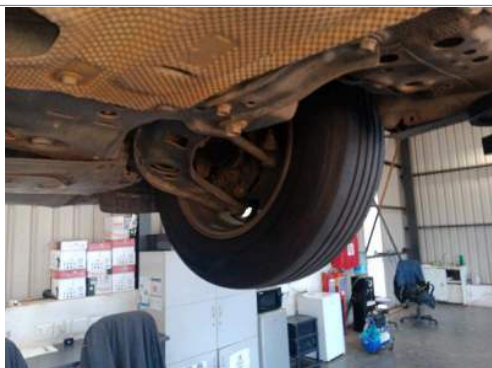
RF TYRE TREAD

| | Size | Load/Speed Index | Manufacture | Model | Type* | Production Date | Tread Depth (mm) |
|---|---|---|---|---|---|---|---|
| Front Right | 215/65R16 | 98H | Royal black | Royal mile | V | 1124 | 4 mm |
