## CONDITION REPORT

Report No:  
2017306440  
DATE  
02/10/2026

| Manufacturer | MITSUBISHI MOTORS | Registration Number | BC40JYGP |
| Model | LANCER 2.0 GLS [2007-2012] | Register Number | |

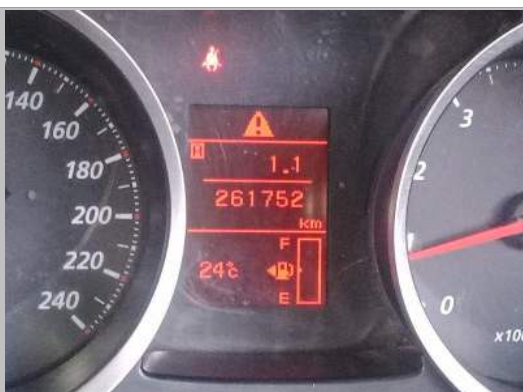
ODOMETER

| Km Reading | 261,751 KM | Fuel | PETROL |

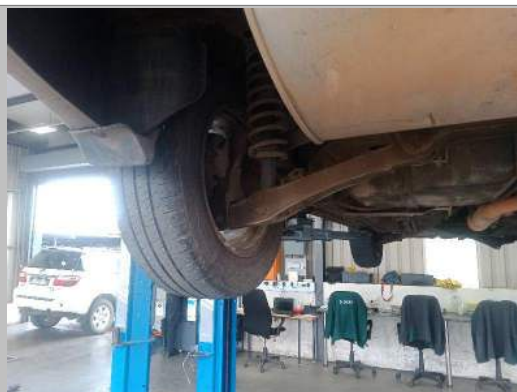
LR TYRE TREAD

| | Size | Load/Speed Index | Manufacture | Model | Type* | Production Date | Tread Depth (mm) |
|---|---|---|---|---|---|---|---|
| Rear Left | 205/60R16 | 107/105T | Nexen | Roadian | V | 0721 | 3 mm |

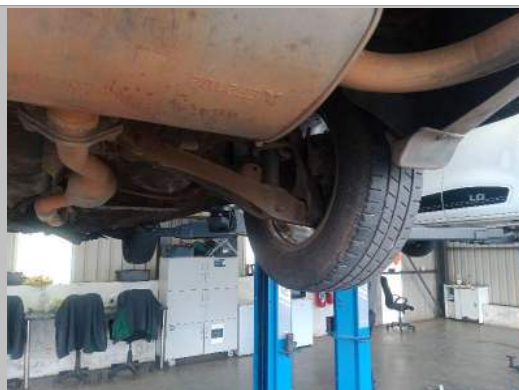
RR TYRE TREAD

| | Size | Load/Speed Index | Manufacture | Model | Type* | Production Date | Tread Depth (mm) |
|---|---|---|---|---|---|---|---|
| Rear Right | 205/65R16 | 107/105T | Goodyear | Vector | V | 4010 | 3 mm |

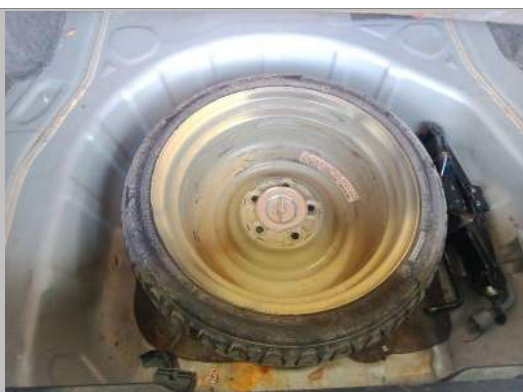
Spare wheel

| | Size | Load/Speed Index | Manufacture | Model | Type* | Production Date | Tread Depth (mm) |
|---|---|---|---|---|---|---|---|
| Spare | T125/70D16 | 96M | Dunlop | Temporary | V | 3609 | 4 mm |
