CONDITION REPORT

Report No: 2016260091

MFC Auction House
M57 Pretoria Rd, Glenmarais, KEMPTON PARK
Gauteng

Vehicle Type	PASSENGER VEHICLE	Registered Owner	MFC AUCTION HOUSE
Manufacturer	MITSUBISHI	Registration Number	HPY327EC
Model	ASX	Register Number	
VIN	JMYXTGA2WFZ002379	Date Of First Licensing	
Engine Number		Last COR	
Doors	5	License Expiry Date	31/03/2024
Color	RED	Power / Displacement	
Year Model		Paint Finish	M - METALLIC
Km Reading	176,655 KM	Fuel	PETROL
Cab / Body Type	STATION WAGON	Transmission	AUTOMATIC

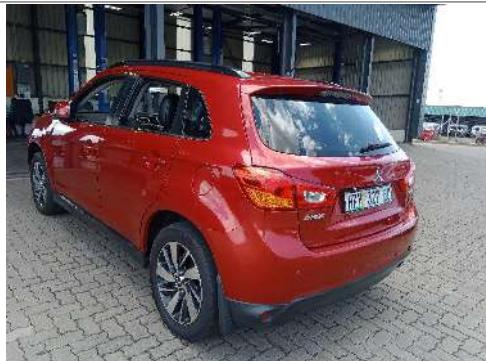
REAR LEFT CORNER

Damage	Repair Way
Engine Oil Leak	Repair
Rear Fender Left Dented	Repair
Door Front Left Paintwork • Scratched	Repair
Tyre Rear Left Smooth	Replace

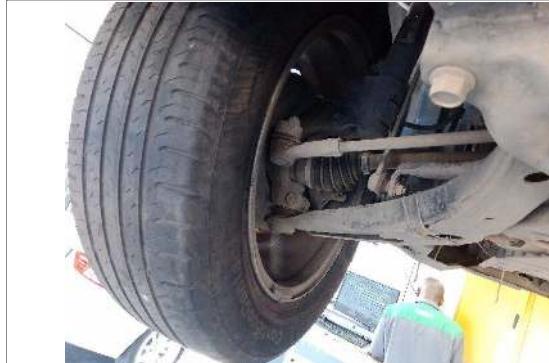
LF TYRE TREAD

Size	Load/Speed Index	Manufacture	Model	Type*	Production Date	Tread Depth (mm)
Front Left	215/60R17	96H	Continental	Contact	V	2319	3 mm
Front Right	215/60R17	96H	Yokohama	Aspec	V	0315	1 mm
Rear Left	215/60R17	96H	Kumho	Solus	V	0319	0 mm
Rear Right	215/60R17	96H	Continental	Contact	V	5017	5 mm
Spare	215/60R17	96H	Kumho	Solus	V	//////	3 mm
