## CONDITION REPORT

Report No:  
2017303166  
DATE  
25/09/2026

| Manufacturer | TOYOTA | Registration Number | KT48KMGP |
| Model | URBAN CRUISER | Register Number | |

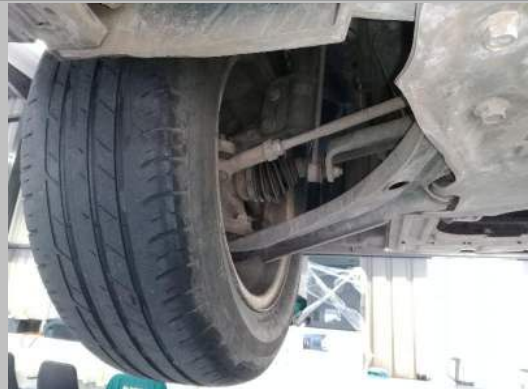
LF TYRE TREAD

| Tyre Front Left Worn | Replace |

| | Size | Load/Speed Index | Manufacture | Model | Type* | Production Date | Tread Depth (mm) |
|---|---|---|---|---|---|---|---|
| Front Left | 215/60 R16 | 95V | Bridgestone | Turanza | V | 3120 | 0 mm |

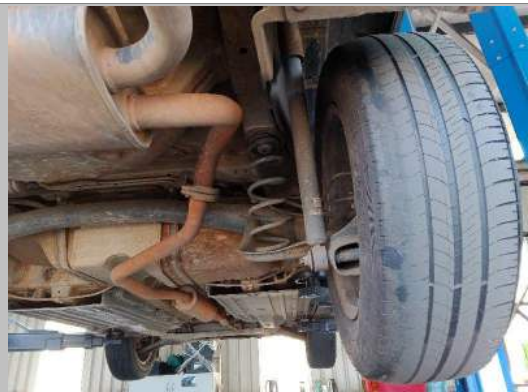
RR TYRE TREAD

| Tyre Rear Right Damaged | Replace |

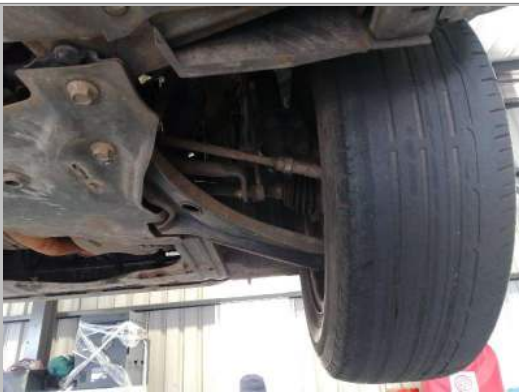
RF TYRE TREAD

| Tyre Front Right Worn | Replace |

| | Size | Load/Speed Index | Manufacture | Model | Type* | Production Date | Tread Depth (mm) |
|---|---|---|---|---|---|---|---|
| Front Right | 215/60 R16 | 95V | Bridgestone | Turanza | V | 3120 | 0 mm |
