MFC Auction House  
M57 Pretoria Rd, Glenmarais, KEMPTON PARK  
Gauteng

| Manufacturer | TOYOTA | Registration Number | LK73ZYGP |

## CONDITION REPORT

Report No: 2016818293

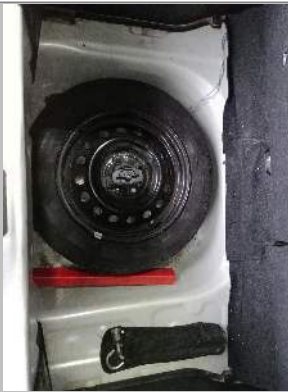
Spare wheel and Accessories

| Damage | Repair Way |
|---|---|
| Spare Tyre Damaged | Replace |
| Rim Spare Wheel Dented | Repair |

| | Size | Load/Speed Index | Manufacture | Model | Type* | Production Date | Tread Depth (mm) |
|---|---|---|---|---|---|---|---|
| Spare | 165/70 R14 | 81S | Bridgestone | Ecopia | V | 0723 | 2 mm |

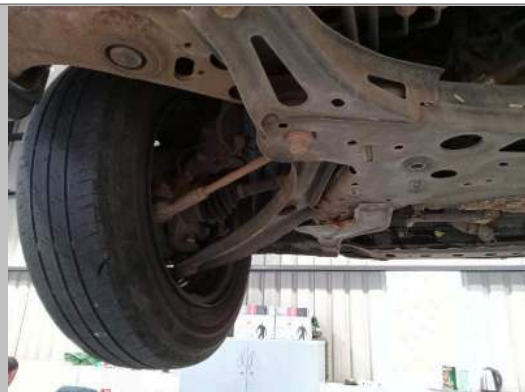
LF TYRE TREAD

| Damage | Repair Way |
|---|---|
| Tyre Front Left Damaged | Replace |

| | Size | Load/Speed Index | Manufacture | Model | Type* | Production Date | Tread Depth (mm) |
|---|---|---|---|---|---|---|---|
| Front Left | 165/70 R14 | 81S | Bridgestone | Ecopia | V | 0823 | 0 mm |

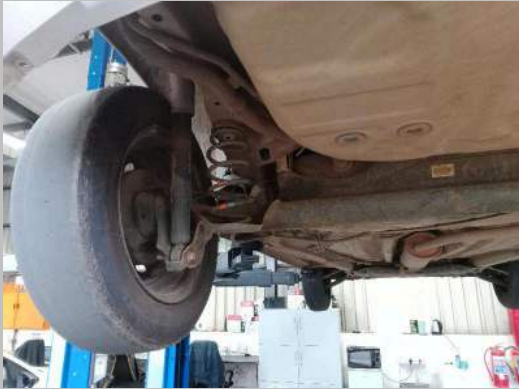
LR TYRE TREAD

| Damage | Repair Way |
|---|---|
| Tyre Rear Left Worn | Replace |

| | Size | Load/Speed Index | Manufacture | Model | Type* | Production Date | Tread Depth (mm) |
|---|---|---|---|---|---|---|---|
| Rear Left | 165/70 R14 | 81S | Bridgestone | Ecopia | V | 0723 | 0 mm |

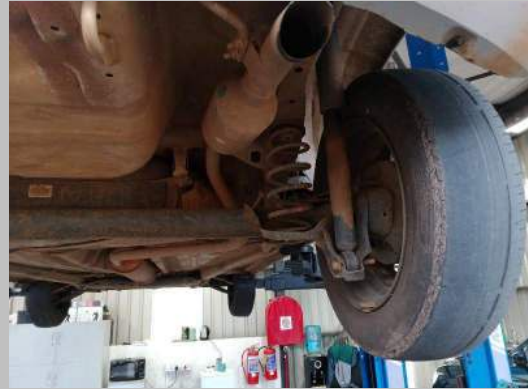
RR TYRE TREAD

| Damage | Repair Way |
|---|---|
| Tyre Rear Right Worn | Replace |

| | Size | Load/Speed Index | Manufacture | Model | Type* | Production Date | Tread Depth (mm) |
|---|---|---|---|---|---|---|---|
| Rear Right | 165/70 R14 | 81S | Bridgestone | Ecopia | V | 0823 | 0 mm |

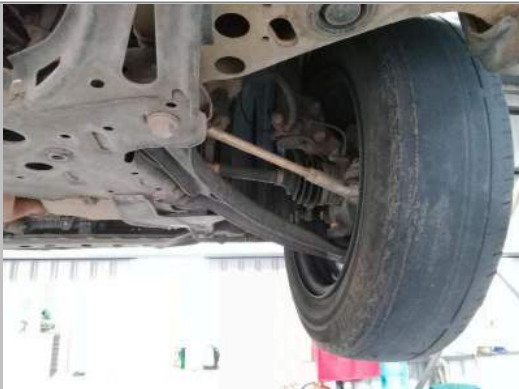
RF TYRE TREAD

| Damage | Repair Way |
|---|---|
| Tyre Front Right Damaged | Replace |

| | Size | Load/Speed Index | Manufacture | Model | Type* | Production Date | Tread Depth (mm) |
|---|---|---|---|---|---|---|---|
| Front Right | 165/70 R14 | 81S | Bridgestone | Ecopia | V | 0823 | 0 mm |
