MFC Auction House
M57 Pretoria Rd, Glenmarais, KEMPTON PARK
Gauteng

VEHICLE INSPECTION

CONDITION REPORT

Report No: 2016370397

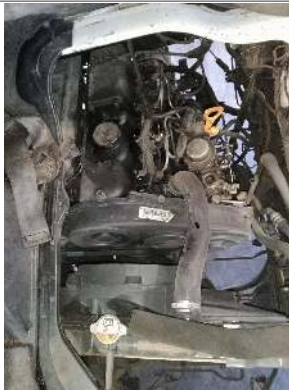
ENGINE 1

Damage	Repair Way
Engine Oil Leak	Repair
Engine Wiring Defective	Repair
Hoses Oil Leak	Repair
Air conditioner pump Damaged	Repair
Air conditioner pipes Defective	Repair
Front Bumper Residual Traces of Repair	Repair
Bonnet Residual Traces of Repair	Repair
Front Fender Left Residual Traces of Repair	Repair
Front Fender Right Residual Traces of Repair	Repair
Windscreen Cracked	Replace
Parking Brake Performance Left / Right Difference out of legal range	Repair
Ball Joint(s) Front Axle Right Damaged	Replace
Tyre Front Left Smooth	Replace
Tyre Front Right Smooth	Replace
Tyre Rear Left Smooth	Replace
Engine to silencer pipe Welded	Replace
Gearbox Oil Leak	Repair
