## CONDITION REPORT

Report No:  
2016999154  
DATE  
02/09/2025

| Manufacturer | HYUNDAI | Registration Number | LR96NLGP |
| Model | H-100 | Register Number | |

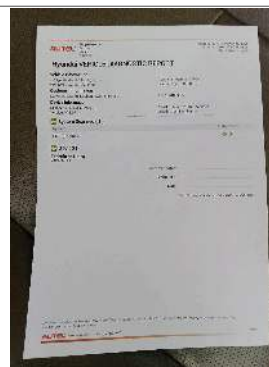
## Shock and brake report

Brakes  
Brake Test Results

| | Left | Right | Axle Weight [KG] | Deceleration [m/s²] |
| | Braking Force [KN] | Braking Force [KN] | | |
| Front | 2.8 | 2.6 | - | |
| Rear | 0.5 | 0.5 | - | |
| Emergency / Parking | 1.2 | 1.8 | - | |

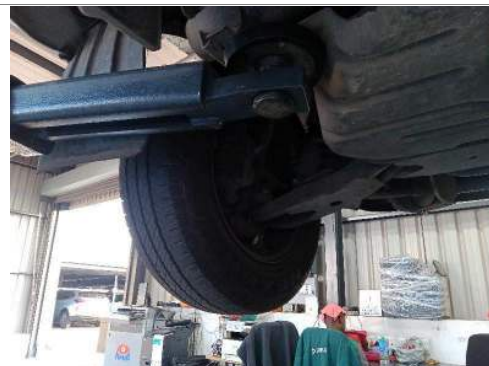
LF TYRE TREAD

| | Size | Load/Speed Index | Manufacture | Model | Type* | Production Date | Tread Depth (mm) |
|---|---|---|---|---|---|---|---|
| Front Left | 195/70R15 | 104/102S | Nexen | Cp321 | V | 2623 | 4 mm |

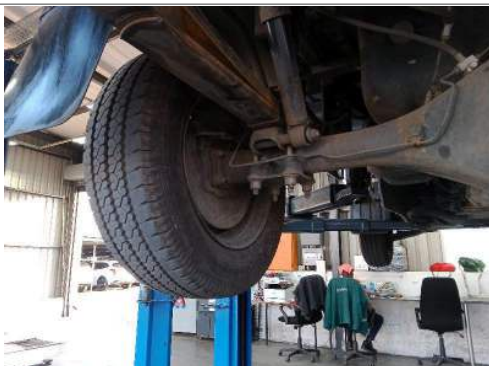
LR TYRE TREAD

| | Size | Load/Speed Index | Manufacture | Model | Type* | Production Date | Tread Depth (mm) |
|---|---|---|---|---|---|---|---|
| Rear Left | 195/70R15 | 104/102R | Royal black | Royal commer | V | 0524 | 4 mm |

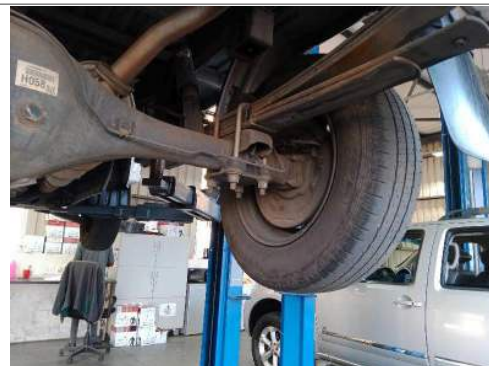
RR TYRE TREAD

| | Size | Load/Speed Index | Manufacture | Model | Type* | Production Date | Tread Depth (mm) |
|---|---|---|---|---|---|---|---|
| Rear Right | 195/70R15 | 104/102S | Nexen | Cp321 | V | 2623 | 3 mm |
