| Manufacturer | HYUNDAI | Registration Number | HJ83HZGP |
| Model | ACCENT | Register Number | |

CONDITION REPORT

Report No: 2016244506

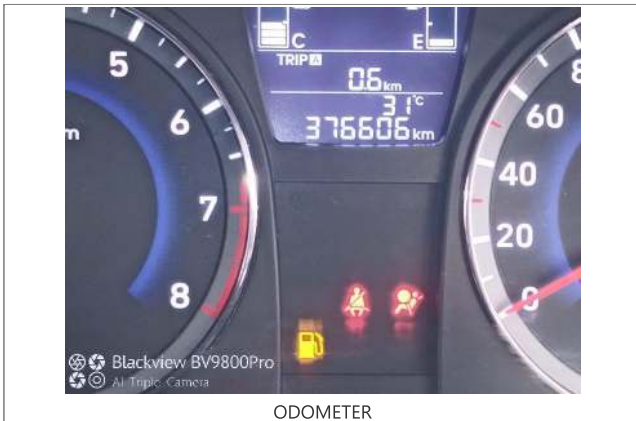
ODOMETER

| Km Reading | 376,606 KM | Fuel | PETROL |

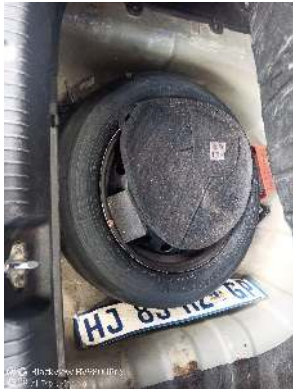
Spare wheel

| Damage | Repair Way |
|---|---|
| Spare Tyre Smooth | Replace |

| | Size | Load/Speed Index | Manufacture | Model | Type* | Production Date | Tread Depth (mm) |
|---|---|---|---|---|---|---|---|
| Spare | 175/65R14 | 82H | Neolin | Neogreen | V | 2621 | 0 mm |

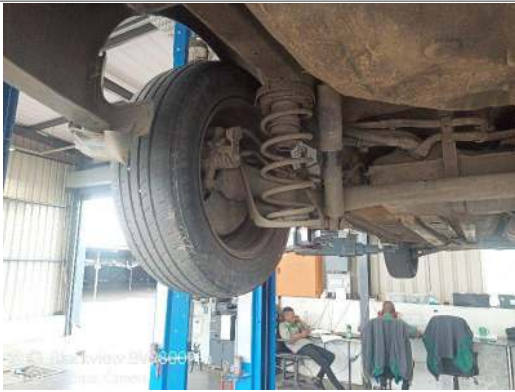
LR TYRE TREAD

| | Size | Load/Speed Index | Manufacture | Model | Type* | Production Date | Tread Depth (mm) |
|---|---|---|---|---|---|---|---|
| Rear Left | 185/60R14 | 82H | Davanti | Dx390 | V | 0820 | 1 mm |

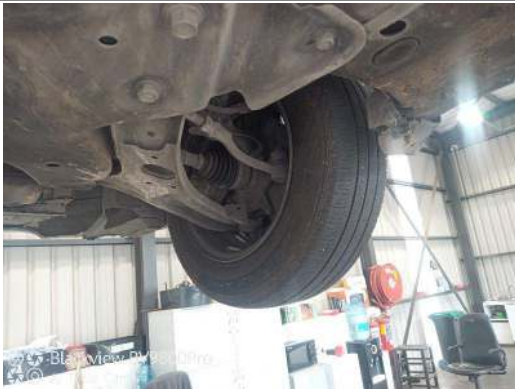
RF TYRE TREAD

| | Size | Load/Speed Index | Manufacture | Model | Type* | Production Date | Tread Depth (mm) |
|---|---|---|---|---|---|---|---|
| Front Right | 185/65R14 | 85H | Nexen | N priz | V | 4722 | 1 mm |
