CONDITION REPORT

Report No: 2016887396

Vehicle Type	PASSENGER VEHICLE	Registered Owner	
Manufacturer	HYUNDAI	Registration Number	HR05FYGP
Model	ACCENT	Register Number	
VIN	KMHCT41DLJU438487	Date Of First Licensing	
Engine Number		Last COR	
Doors	4	License Expiry Date	31/08/2019
Color	GREY	Power / Displacement	
Year Model		Paint Finish	M - METALLIC
Km Reading	301,409 KM	Fuel	PETROL
Cab / Body Type	SEDAN	Transmission	MANUAL

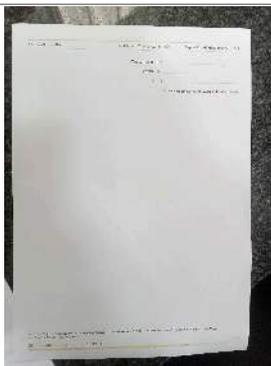
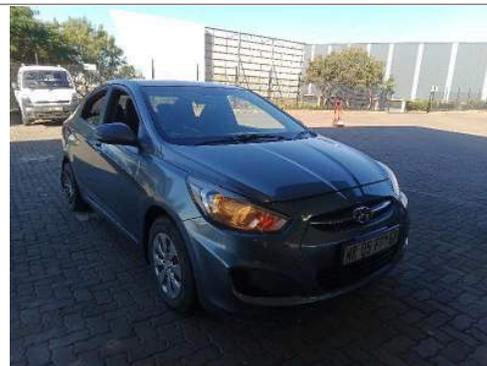
Diagnostic test

No	System	Code	Description	Status
1	ENGINE	P0268	CYLINDER 3 INJECTOR CIRCUIT HIGH
