CONDITION REPORT

Report No:
2016947361
DATE
15/07/2025

MFC Auction House
M57 Pretoria Rd, Glenmarais, KEMPTON PARK
Gauteng

Vehicle Type	PASSENGER VEHICLE	Registered Owner	
Manufacturer	HYUNDAI	Registration Number	DL80XJGP
Model	ACCENT 1.6 FLUID 6-SP [2013-2021]	Register Number	
VIN	KMHCU41DLFU812502	Date Of First Licensing	
Engine Number		Last COR	
Doors	4	License Expiry Date	31/08/2025
Color	GREY	Power / Displacement	
Year Model	2014	Paint Finish	M - METALLIC
Km Reading	616,861 KM	Fuel	PETROL
Cab / Body Type	SEDAN	Transmission	MANUAL

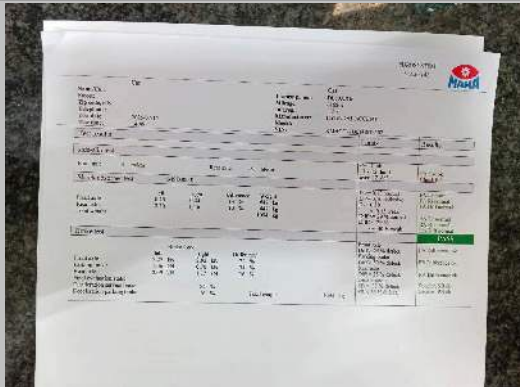
Shock and brake report

Left	Right		
	Braking Force [KN]	Braking Force [KN]	Axle Weight [KG]	Deceleration [m/s ²]
Front	2.2	2.9	-	
Rear	2.0	1.7	-	
Emergency / Parking	1	0.7	-

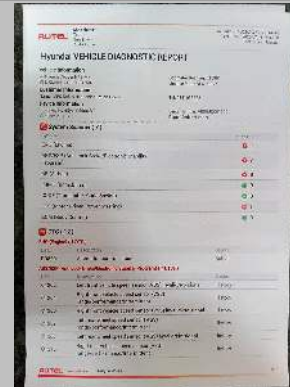
Diagnostic test

No	System	Code	Description	Status
1	ENGINE	P0620	ALTERNATOR CONTROL CIRCUIT ENGINE

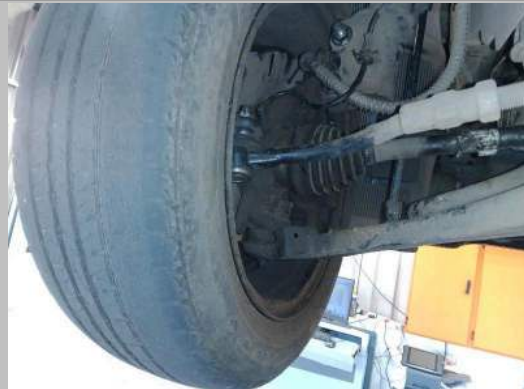
LF TYRE TREAD

Size	Load/Speed Index	Manufacture	Model	Type*	Production Date	Tread Depth (mm)
Front Left	165/65R14	79H	Aplus	S600	V	0000	0 mm
Front Right	165/60R14	75H	Autogrip	Grip200	V	0000	0 mm
Rear Left	165/65R14	79T	General	Altimax	V	4418	1 mm
Rear Right	185/65R14	86H	Firestone	Touring	V	0000	0 mm
Spare	165/60R14	75H	Double king	DK558	V	0000	0 mm

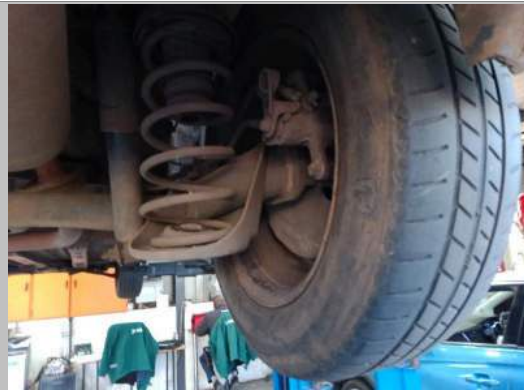
RR TYRE TREAD

Tyre Rear Right Excessive Wear & Tear	Replace
Spare Tyre Smooth	Replace
Rim Rear Left Damaged	Replace
Gearbox Oil Leak	Repair
CV Joint(s) Boot(s) Front Right (inner/outer) Damaged	Replace
Gear Selections Insufficient	Repair
No battery	Replace
Front tyre size differs	Replace
Rear tyre size differs	Replace
Warning lights illuminated	Repair
Front suspension excessive noise	Repair

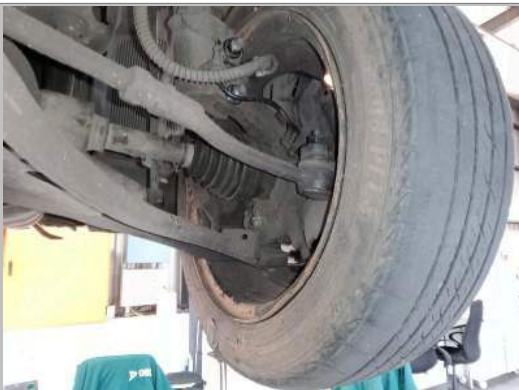
RF TYRE TREAD

Damage	Repair Way
Engine Oil Leak	Repair
Head Light Switch Damaged	Replace
Switch Electrical Window Winder front left Defective	Repair
Seat Front Right Torn / Cut	Repair
Rear Lower Valance Damaged	Repair
Front Bumper Residual Traces of Repair	Repair
Front Fender Left Residual Traces of Repair	Repair
Rear Fender Left Residual Traces of Repair	Repair
Rear Fender Right Dented	Repair
Rear Fender Right / Inner Tray Residual Traces of Repair	Repair
Door Front Left Residual Traces of Repair	Repair
Door Front Right Residual Traces of Repair	Repair
Rear bumper Residual Traces of Repair	Repair
Sill Panel Left Damaged	Repair
Roof Dented	Repair
Tie Rod End left Damaged	Replace
Split Pin Left Missing	Replace
Stabilizer Mounting Front Left Damaged	Replace
Control Arm Bush(es) Front Axle Left Cracked	Replace
Control Arm Bush(es) Front Axle Right Cracked	Replace
Tyre Front Left Smooth	Replace
Tyre Front Right Torn / Cut	Replace

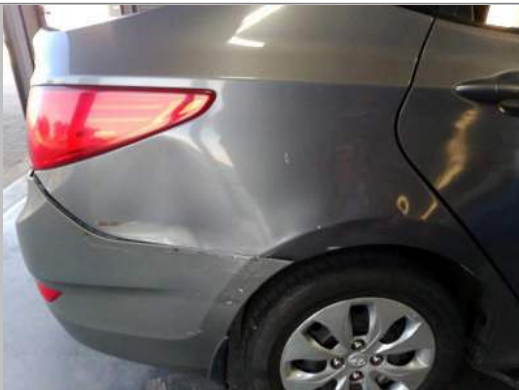
Rear Fender Right

General Comments: ACCORDING TO THE AGE AND MILEAGE OF THE VEHICLE, NORMAL WEAR AND TEAR MARKS ARE VISIBLE ON THE INTERIOR, EXTERIOR, ELECTRICAL AND MECHANICAL PARTS. Body • Exterior: Residual traces of poor repair on most body panels. Signs of spray work done on most body panels.

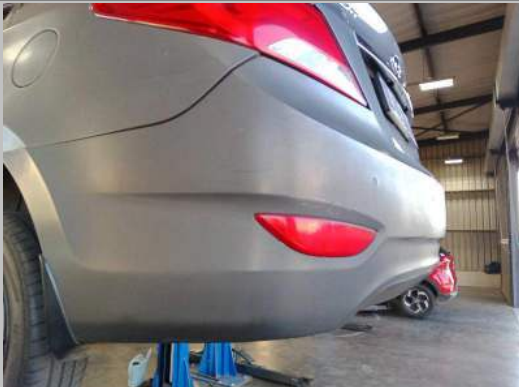
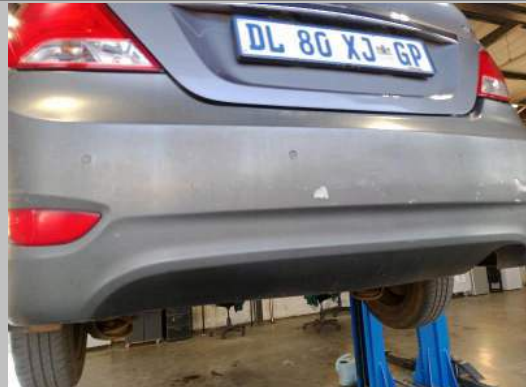
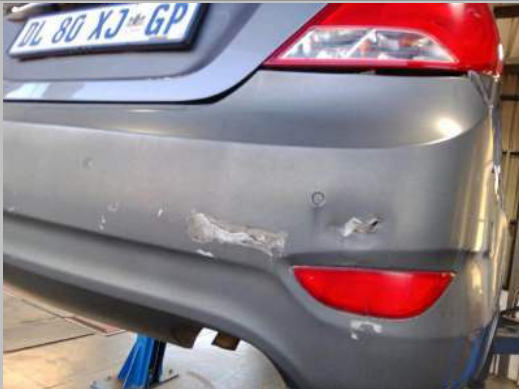
Rear bumper
