MFC Auction House
M57 Pretoria Rd, Glenmarais, KEMPTON PARK
Gauteng

DEKRA MFC
M57 Pretoria Rd - 1619
KEMPTON PARK - GT
08610 33572

VEHICLE INSPECTION

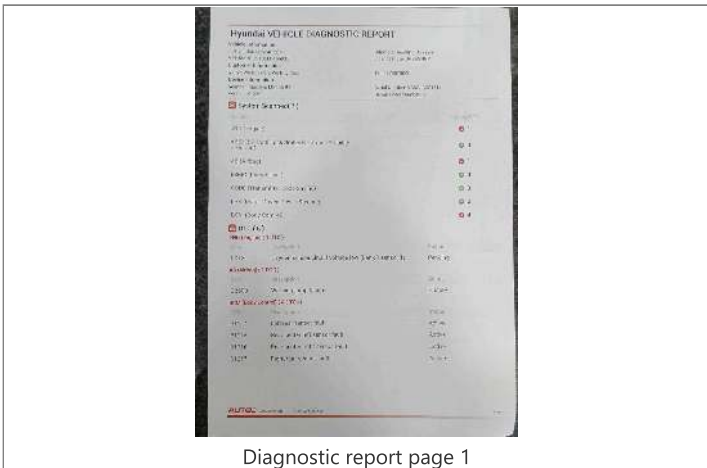
Diagnostic report page 1

No	System	Code	Description	Status
1	ENG(ENGINE)	P0131	OXYGEN SENSOR CIRCUIT VOLTAGE LOW(BANK 1 SENSOR 1)

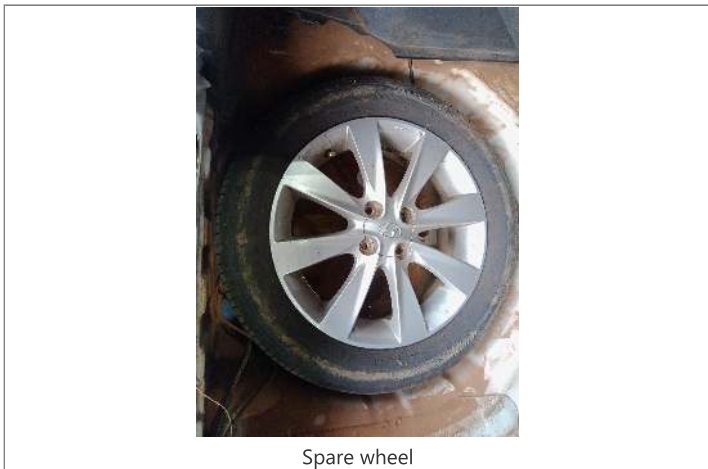
Spare wheel

Damage	Repair Way
Rear Fender Right / Inner Tray Defective	Repair
Door Front Left Dented	Repair
Door Front Right Paintwork • Scratched	Repair
Door Rear Left Dented	Repair
Door Rear Right Paintwork • Scratched	Repair
Boot Lid / Hatch door Damaged	Replace
Rear bumper Damaged	Repair
Inner Boot Floor Pan and Spare Wheel Well Damaged	Repair
Rocker Panel Left Damaged	Repair
Rocker Panel Right Damaged	Repair
Roof Paintwork • Chipmarks	Repair
Windscreen Cracked	Replace
Brake disc 1. Axle right Defective	Replace
Service Brake Performance Rear Axle Left / Right	Repair
Difference out of legal range	Repair
Control Arm Bush(es) Front Axle Left Cracked	Replace
Control Arm Bush(es) Front Axle Right Cracked	Replace
Mounting Rubber(s) Rear Axle Left Cracked	Replace
Mounting Rubber(s) Rear Axle Right Cracked	Replace
Tyre Front Left Worn	Replace
Tyre Rear Left Worn	Replace
Spare Tyre Damaged	Replace
Rim Front Left Scratched	Repair

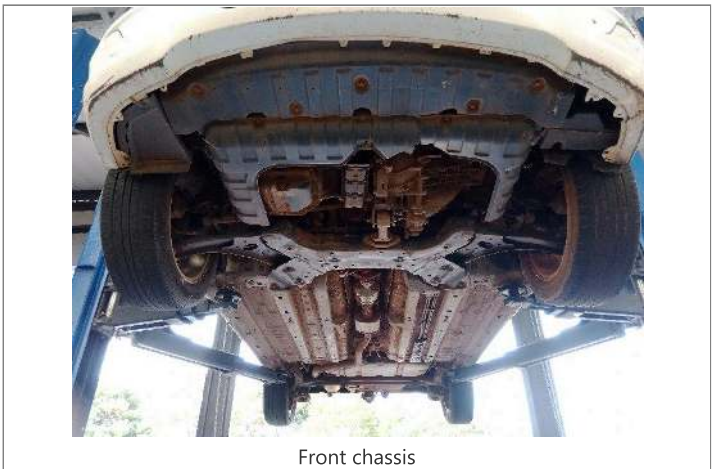
Front chassis

Rim Rear Right Scratched	Repair
Main Beam Left Damaged	Repair
Chassis Dented	Repair
Sub Frame Dented	Repair
Belly plates Damaged	Replace
Fuel Tank Dented	Repair
CV Joint(s) Boot(s) Front Left (inner/outer) Damaged	Replace
Engine Noise Excessive	Repair
Vehicle key fob casing defective	Replace

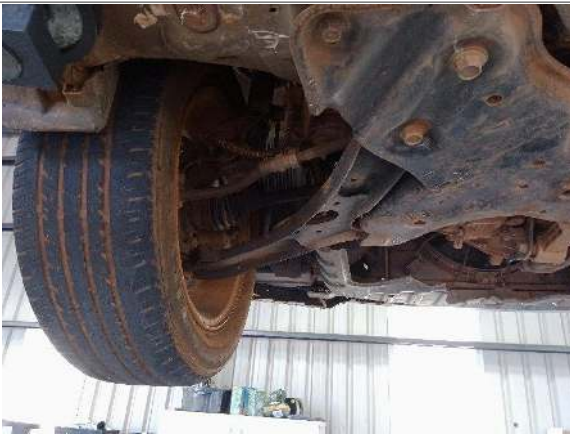
LF TYRE TREAD

Size	Load/Speed Index	Manufacture	Model	Type*	Production Date	Tread Depth (mm)
Front Left	205/55 R16	91V	Firestone	Touring	V	3416	0 mm
Front Right	205/55 R16	91V	Duran	L919	V	4420	1 mm
Rear Left	205/55 R16	91V	Duran	L919	V	4420	0 mm
Rear Right	205/55 R16	91V	Duran	L919	V	4420	1 mm
Spare	205/55 R16	91V	Duran	L919	V	4420	3 mm

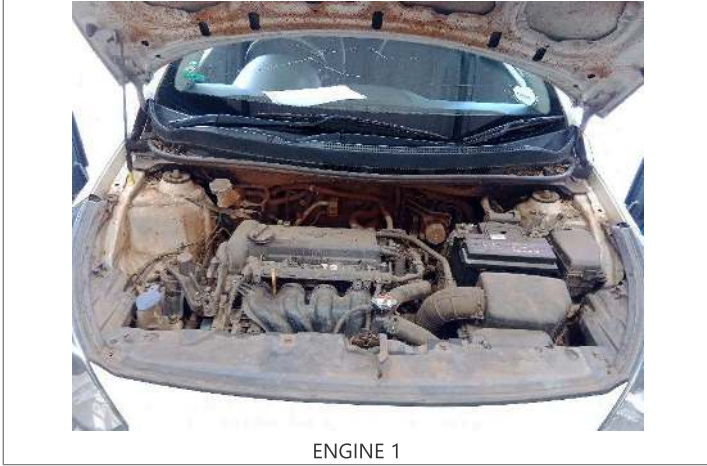
ENGINE 1

Damage	Repair Way
Engine Oil Leak	Repair
Engine Wiring Defective	Repair
Hoses Defective	Replace
Air cleaner Defective	Repair
Windscreen Wiper Damaged	Replace
Park Light Front Left Defective	Replace
Park Light Front Right Defective	Replace
Tail Light Left Damaged	Replace
Headlight Left Defective	Repair
Headlight Right Defective	Repair
Seat Front Left Dirty	Repair
Seat Front Right Dirty	Repair
Seat Rear Dirty	Repair
Sun Visor Left Dirty	Repair
Sun Visor Right Dirty	Repair
Hood Lining Dirty	Repair
Door Sealing Rubber Rear Right Defective	Repair
Boot Carpet Damaged	Repair
Steering Wheel Trim Defective	Repair
Side Mirror Left Damaged	Replace
Side Mirror Right Paintwork • Scratched	Repair
Front Bumper Damaged	Repair
Bonnet Paintwork • Chipmarks	Repair
Front Fender Left Paintwork • Scratched	Repair
Front Fender Right Paintwork • Scratched	Repair
Rear Fender Left Damaged	Repair
Rear Fender Right Dented	Repair
Front Fender Left / Inner Tray Damaged	Replace

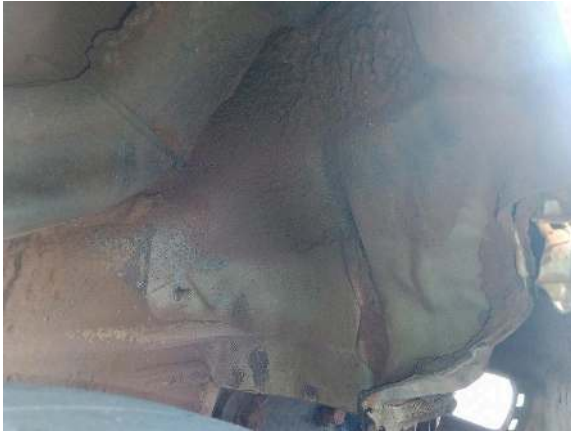
Rear Fender Left / Inner Tray Damaged	Repair
