MFC Auction House
M57 Pretoria Rd, Glenmarais, KEMPTON PARK
Gauteng

| Manufacturer | HYUNDAI | Registration Number | HY01KLGP |

CONDITION REPORT

Report No: 2016317760

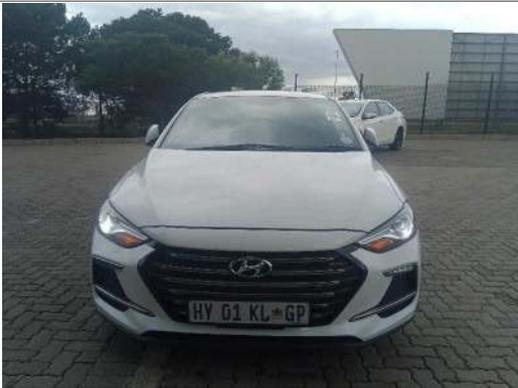
90 DEGREE FRONT

| Damage | Repair Way |
|--|---|
| Front Bumper Paintwork • Scratched | Repair |

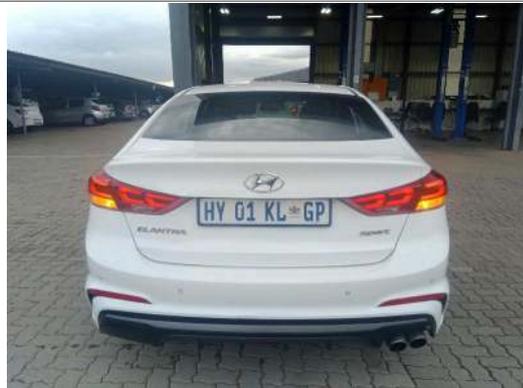
90 DEGREE REAR

| Damage | Repair Way |
|--|---|
| Rear bumper Paintwork • Scratched | Repair |

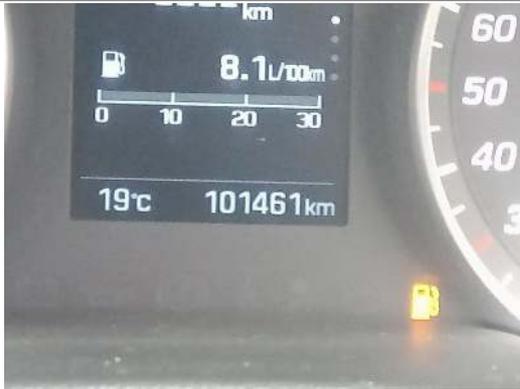
ODOMETER

| Km Reading | 101,461 KM | Fuel | PETROL |

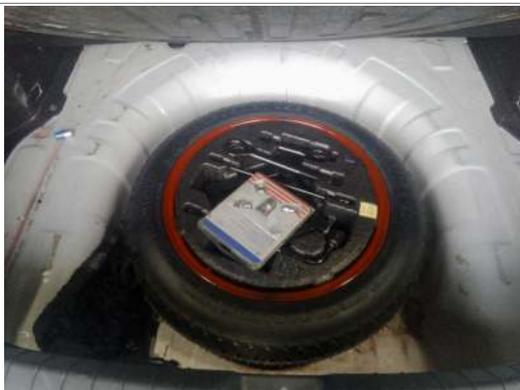
Sparewheel

| | Size | Load/Speed Index | Manufacture | Model | Type* | Production Date | Tread Depth (mm) |
|---|---|---|---|---|---|---|---|
| Spare | T125/80D16 | 97M | Hankook | Temporary | V | 0000 | 5 mm |
