MFC Auction House  
M57 Pretoria Rd, Glenmarais, KEMPTON PARK  
Gauteng

DEKRA MFC  
M57 Pretoria Rd - 1619  
KEMPTON PARK - GT  
08610 33572

## Assignment

## VEHICLE INSPECTION

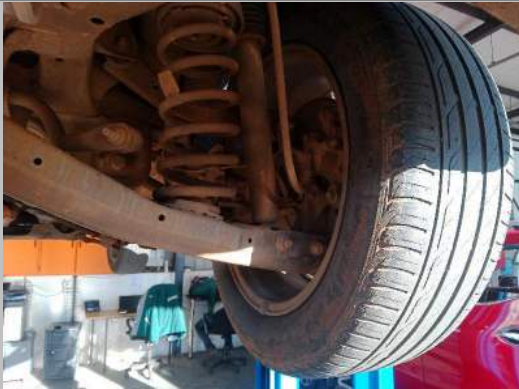
RR TYRE TREAD

| | Size | Load/Speed Index | Manufacture | Model | Type* | Production Date | Tread Depth (mm) |
|---|---|---|---|---|---|---|---|
| Rear Right | 215/55R17 | 94V | Bridgestone | Turanza | V | | 2 mm |

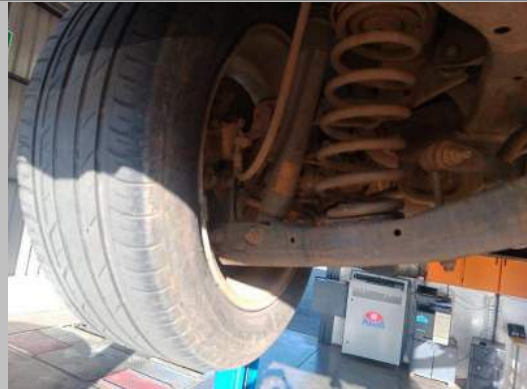
LR TYRE TREAD

| | Size | Load/Speed Index | Manufacture | Model | Type* | Production Date | Tread Depth (mm) |
|---|---|---|---|---|---|---|---|
| Rear Left | 215/55R17 | 94V | Bridgestone | Turanza | V | 1121 | 5 mm |

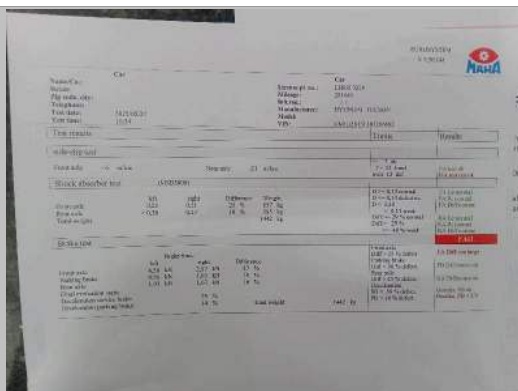
SHOCK & BRAKE REPORT

| Damage | Repair Way |
|---|---|
| Service Brake Performance Front Axle Left / Right | Repair |
| Difference out of legal range | Repair |

| | Left | Right | | |
|---|---|---|---|---|
| Front | 4.5 | 2.8 | - | |
| Rear | 1.9 | 1.6 | - | |

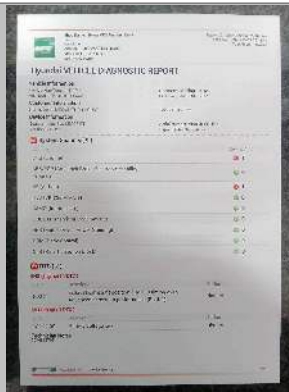
| No | System | Code | Description | Status |
|---|---|---|---|---|
| 1 | AIRBAG | B1102:00 | BATTERY VOLTAGE LOW | |

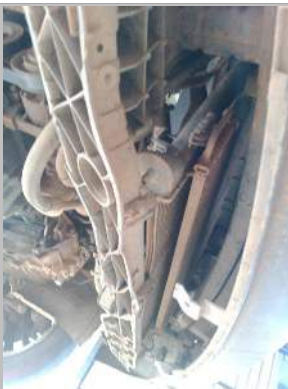
| Damage | Repair Way |
|---|---|
| Radiator Cradle Damaged | Replace |

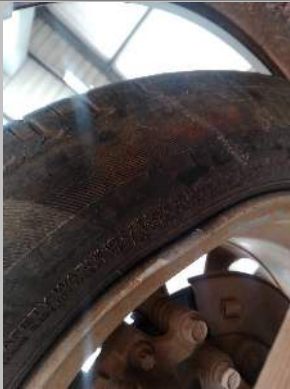
| Damage | Repair Way |
|---|---|
| Rim Rear Left Dented | Repair |
