MFC Auction House
M57 Pretoria Rd, Glenmarais, KEMPTON PARK
Gauteng

DEKRA MFC
M57 Pretoria Rd - 1619
KEMPTON PARK - GT
08610 33572

VEHICLE INSPECTION

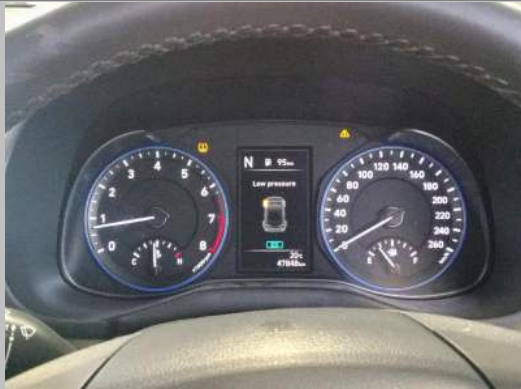
DASHBOARD (W/ ENGINE RUNNING)

Headlight Left Damaged
Tyre Front Left Torn / Cut
Tyre Front Right Excessive Wear & Tear
Some body panels misaligned
Warning lights illuminated

No	System	Code	Description	Status
1	IGPM	B2352:00	DEDICATED DRL LEFT CIRCUIT SHORT TO GROUND

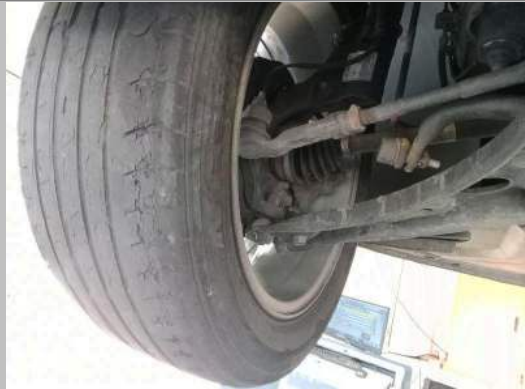
LF TYRE TREAD

Size	Load/Speed Index	Manufacture	Model	Type*	Production Date	Tread Depth (mm)
Front Left	215/55R17	94V	Nexen	Nfera	V	0000	0 mm
Front Right	215/55R17	94V	Nexen	Nfera	V	0000	0 mm
Rear Left	215/55R17	94V	Nexen	Nfera	V	0000	1 mm
Rear Right	215/55R17	94V	Nexen	Nfera	V	0000	2 mm
Spare	T125/80D16	97M	Kumho	Temporary	V	0000	2 mm

Repair
Replace
Replace
Repair
Repair
