MFC Auction House  
M57 Pretoria Rd, Glenmarais, KEMPTON PARK  
Gauteng

| Vehicle Type | MINI BUS | Registered Owner | MFC |

## CONDITION REPORT

Report No: 201623809

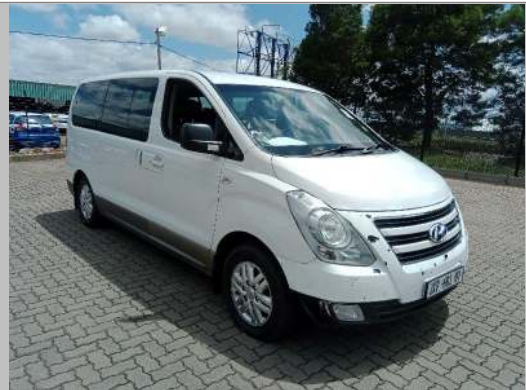
FRONT RIGHT CORNER

Poor residual traces of repair on some body panels. Front left inner fender liner missing and right inner fender liner damaged. Signs of impact damage to front and rear of vehicle.

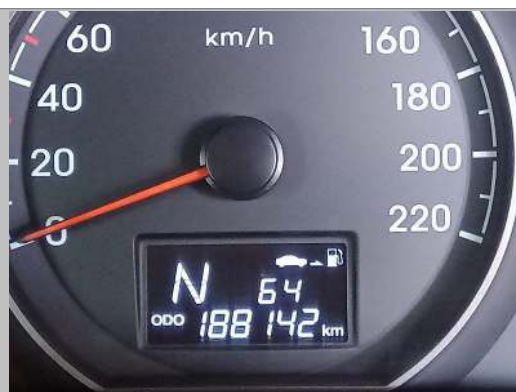
ODOMETER

| Km Reading | 188,142 KM | Fuel | DIESEL |

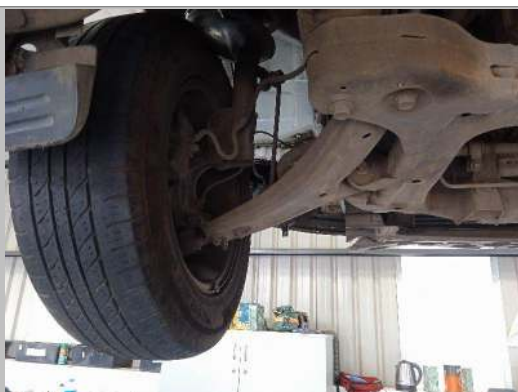
LF TYRE TREAD

| | Size | Load/Speed Index | Manufacture | Model | Type* | Production Date | Tread Depth (mm) |
|---|---|---|---|---|---|---|---|
| Front Left | 215/65 R16 | 98H | Westlake | SU318 | V | 3421 | 2 mm |

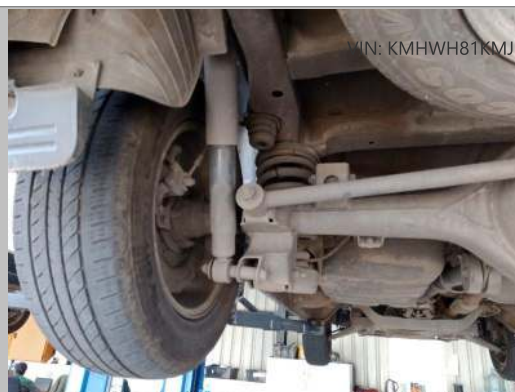
LR TYRE TREAD

| Damage | Repair Way |
|---|---|
| Tyre Rear Left Damaged | Replace |

| | Size | Load/Speed Index | Manufacture | Model | Type* | Production Date | Tread Depth (mm) |
|---|---|---|---|---|---|---|---|
| Rear Left | 215/65 R16 | 98H | Westlake | SU318 | V | 3521 | 5 mm |

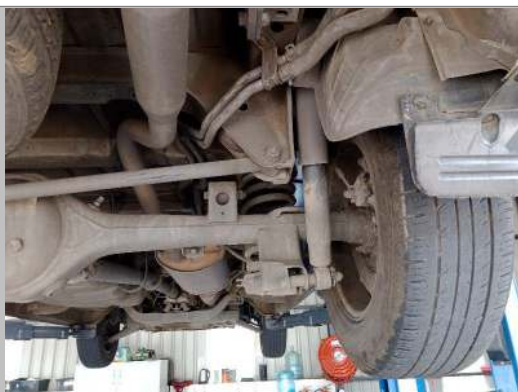
RR TYRE TREAD

| | Size | Load/Speed Index | Manufacture | Model | Type* | Production Date | Tread Depth (mm) |
|---|---|---|---|---|---|---|---|
| Rear Right | 215/65 R16 | 98H | Westlake | SU318 | V | 3421 | 4 mm |

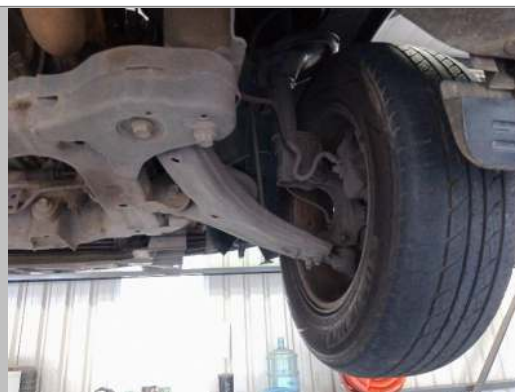
RF TYRE TREAD

| Damage | Repair Way |
|---|---|
| Tyre Front Right Worn | Replace |

| | Size | Load/Speed Index | Manufacture | Model | Type* | Production Date | Tread Depth (mm) |
|---|---|---|---|---|---|---|---|
| Front Right | 215/65 R16 | 98H | Westlake | SU318 | V | 3521 | 0 mm |

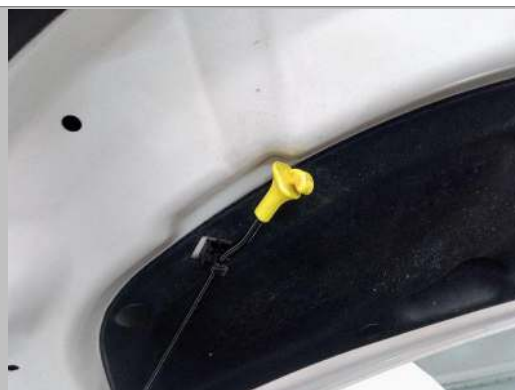
| | Damage | Repair Way |
|---|---|---|
| | Bonnet stay and shocks Defective | Repair |
