## CONDITION REPORT

Report No:  
2017302491  
DATE  
23/09/2026

| Manufacturer | KIA | Registration Number | JWH057MP |
| VIN | KNAB2511MKT365271 | Date Of First Licensing | |

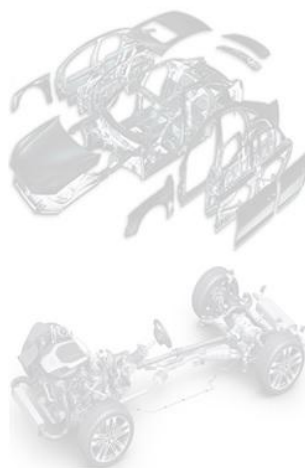
Engine Management Lights Set  
 Windscreen Wiper Damaged  
 Tail Light Left Damaged  
 Headlight Left Damaged  
 Headlight Right Damaged  
 Front Bumper Damaged  
 Bonnet Damaged  
 Front Fender Left Damaged  
 Front Fender Right Damaged  
 Rear Fender Left Damaged  
 Rear Fender Right Damaged  
 Door Front Left Damaged  
 Door Front Right Damaged  
 Door Rear Left Damaged  
 Door Rear Right Damaged  
 Boot Lid / Hatch door Damaged  
 Rear bumper Defective  
 Roof Damaged  
 Windscreen Damaged  
 Radiator Cradle Damaged

Repair  
 Replace  
 Replace  
 Replace  
 Replace  
 Repair  
 Repair  
 Repair  
 Repair  
 Repair  
 Repair  
 Repair  
 Repair  
 Repair  
 Repair  
 Repair  
 Replace  
 Replace

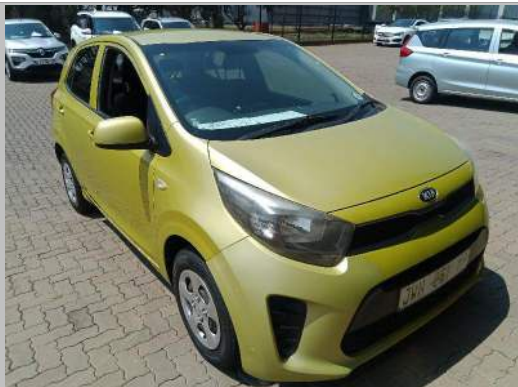
FRONT RIGHT CORNER

Body • Exterior: Minor dents and scratches and stone chips to body panels. Signs of repair work done to body panels. Poor alignment to somebody panels. Signs of hail damage to some body panels.

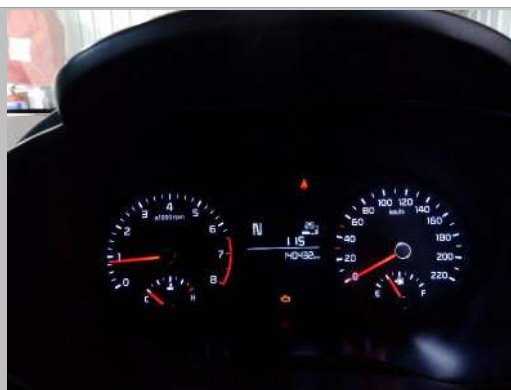
DASHBOARD (W/ ENGINE RUNNING)

| No | System | Code | Description | Status |
|---|---|---|---|---|
| 1 | ENG | P0202:00 | CYLINDER 2 INJECTOR CIRCUIT OPEN | |

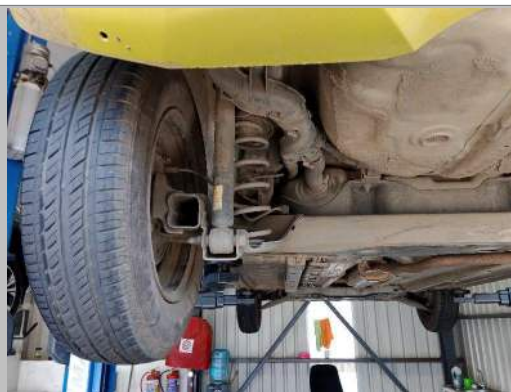
LR TYRE TREAD

| | Size | Load/Speed Index | Manufacture | Model | Type* | Production Date | Tread Depth (mm) |
|---|---|---|---|---|---|---|---|
| Rear Left | 155/80R13 | 79T | Sailun | Radial | V | 3824 | 2 mm |

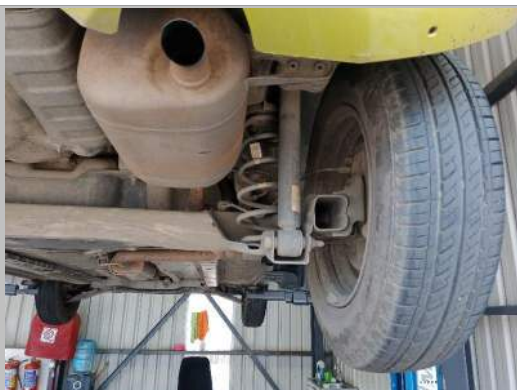
RR TYRE TREAD

| | Size | Load/Speed Index | Manufacture | Model | Type* | Production Date | Tread Depth (mm) |
|---|---|---|---|---|---|---|---|
| Rear Right | 155/80R13 | 79T | Sailun | Radial | V | 3524 | 3 mm |

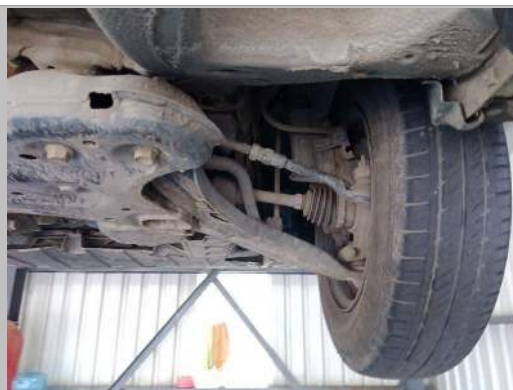
RF TYRE TREAD

| | Size | Load/Speed Index | Manufacture | Model | Type* | Production Date | Tread Depth (mm) |
|---|---|---|---|---|---|---|---|
| Front Right | 155/80R13 | 79T | Sailun | Radial | V | 3524 | 2 mm |

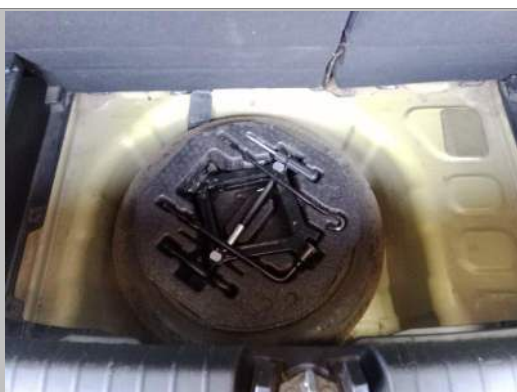
spare wheel.

| | Size | Load/Speed Index | Manufacture | Model | Type* | Production Date | Tread Depth (mm) |
|---|---|---|---|---|---|---|---|
| Spare | T115/70D15 | 90M | Maxxis | Temporary | V | //// | 2 mm |

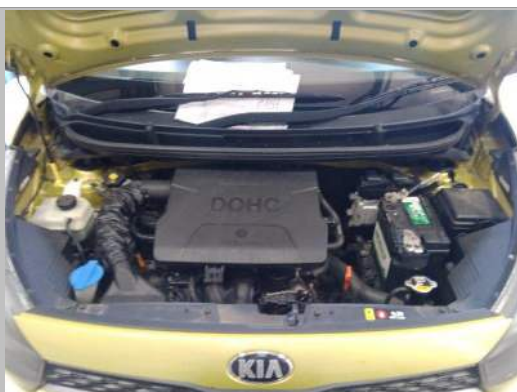
ENGINE 1

General Comments: ACCORDING TO THE AGE AND MILEAGE OF THE VEHICLE, NORMAL WEAR AND TEAR MARKS ARE VISIBLE ON THE INTERIOR, EXTERIOR, ELECTRICAL AND MECHANICAL PARTS. Engine Compartment: dipstick damaged. oil level could not be checked correctly. battery loose.
