## CONDITION REPORT

Report No: 2016886862

| Manufacturer | KIA | Registration Number | JHY232MP |
| Model | PICANTO | Register Number | |

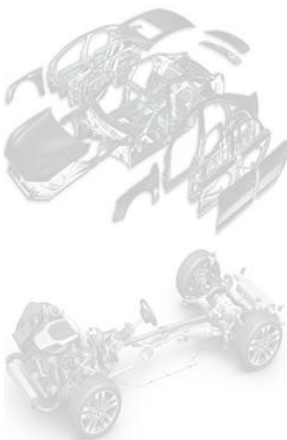
Windscreen Wiper Missing  
Front Bumper Paintwork • Scratched  
Front Fender Left Damaged  
Windscreen Cracked

Replace  
Repair  
Repair  
Replace

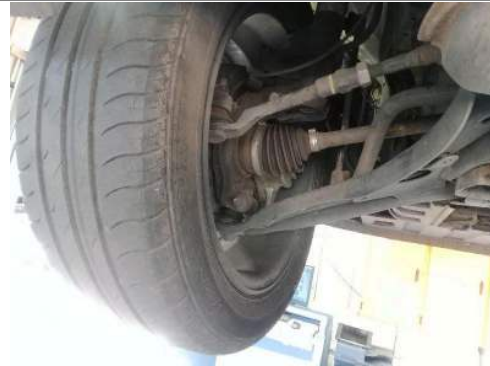
LF TYRE TREAD

| | Size | Load/Speed Index | Manufacture | Model | Type* | Production Date | Tread Depth (mm) |
|---|---|---|---|---|---|---|---|
| Front Left | 185/55R15 | 86H | Nexen | Nblue | V | 2617 | 5 mm |

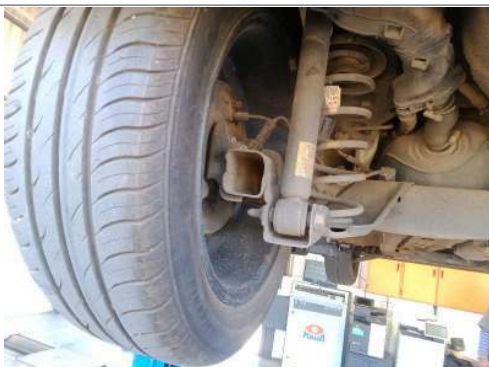
LR TYRE TREAD

| | Size | Load/Speed Index | Manufacture | Model | Type* | Production Date | Tread Depth (mm) |
|---|---|---|---|---|---|---|---|
| Rear Left | 185/55R15 | 86H | Nexen | Nblue | V | 2617 | 5 mm |

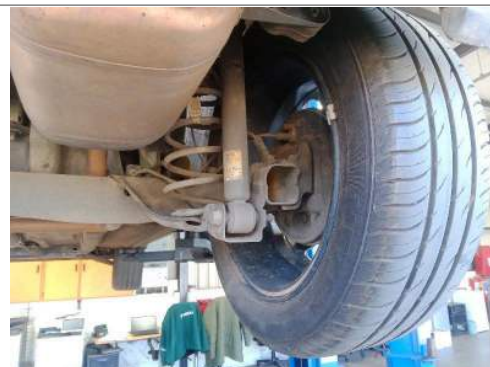
RR TYRE TREAD

| | Size | Load/Speed Index | Manufacture | Model | Type* | Production Date | Tread Depth (mm) |
|---|---|---|---|---|---|---|---|
| Rear Right | 185/55R15 | 86H | Nexen | Nblue | V | 2617 | 6 mm |

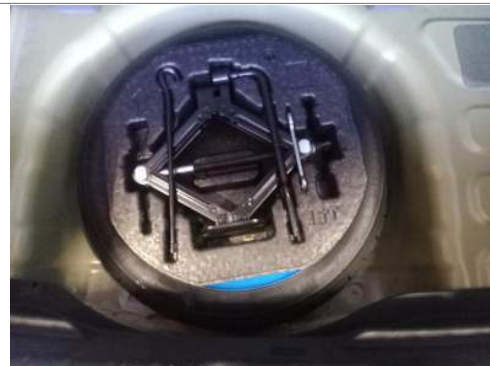
Sparewheel

| | Size | Load/Speed Index | Manufacture | Model | Type* | Production Date | Tread Depth (mm) |
|---|---|---|---|---|---|---|---|
| Spare | T115/70D16 | 90M | Maxxis | Temporary | V | 0000 | 5 mm |
