## CONDITION REPORT

Report No: 2016867939

MFC Auction House  
M57 Pretoria Rd, Glenmarais, KEMPTON PARK  
Gauteng

Vehicle Type	PASSENGER VEHICLE	Registered Owner	
Manufacturer	KIA	Registration Number	DW40JJGP
Model	PICANTO	Register Number	
VIN	KNABE511LGT097544	Date Of First Licensing	
Engine Number		Last COR	
Doors	5	License Expiry Date	31/07/2025
Color	GREY	Power / Displacement	
Year Model		Paint Finish	M - METALLIC
Km Reading	216,675 KM	Fuel	PETROL
Cab / Body Type	HATCHBACK	Transmission	MANUAL

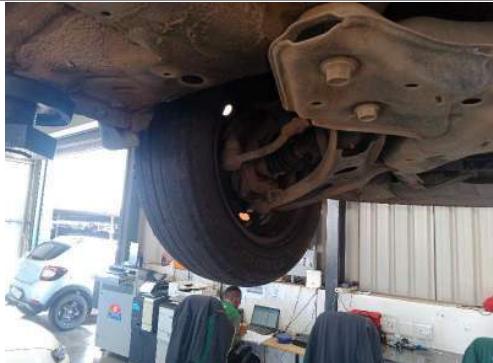
LF TYRE TREAD

Size	Load/Speed Index	Manufacture	Model	Type*	Production Date	Tread Depth (mm)
Front Left	165/65R14	79T	Kumho	Ecowing	V	2618	0 mm
Front Right	155/65R14	75T	Goodyear	Efficient gr	V	1422	0 mm
Rear Left	155/80R13	79T	Good ride	Radial Rp28	V	0619	2 mm
Rear Right	T115/70D14	88M	Bridgestone	Temporary	V	3807	0 mm
Spare	175/65R14	82H	Goodyear	Efficient gr	V	0000	2 mm

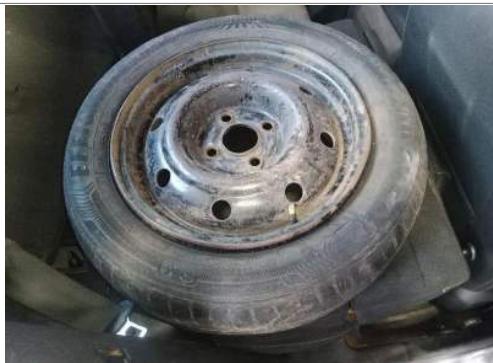
Spare wheel fitted

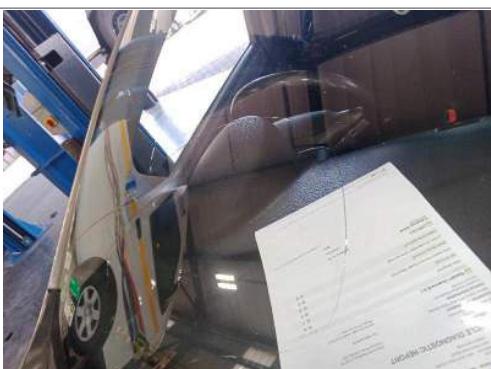
Damage	Repair Way
Seat Front Right Torn / Cut	Repair
Side Mirror Left Paintwork • Scratched	Repair
Side Mirror Right Paintwork • Scratched	Repair
Front Bumper Paintwork • Scratched	Repair
Front Fender Left Dented	Repair
Front Fender Right Dented	Repair
Rear Fender Left Dented	Repair
Rear Fender Right Dented	Repair
Door Front Left Paintwork • Scratched	Repair
Door Front Right Dented	Repair
Door Rear Left Dented	Repair
Door Rear Right Paintwork • Scratched	Repair
Boot Lid / Hatch door Dented	Repair
Rear bumper Paintwork • Scratched	Repair
Windscreen Cracked	Replace
Tyre Front Left Smooth	Replace
Tyre Front Right Smooth	Replace
Tyre Rear Right Smooth	Replace
Bolt(s) / Nut(s) Rear Wheel Right Defective	Repair
Boot not opening	Repair
