MFC Auction House  
M57 Pretoria Rd, Glenmarais, KEMPTON PARK  
Gauteng

| Manufacturer | KIA | Registration Number | KN04MWGP |
| Model | PICANTO 1.0 LS 5-DR [2015-2018] | Register Number | |

## VEHICLE INSPECTION

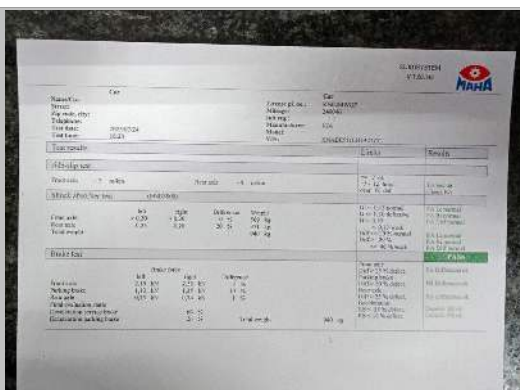
## Shock and brake report

| | Left | Right | | |
|---|---|---|---|---|
| Front | 2.1 | 2.3 | - | |
| Rear | 0.7 | 0.7 | - | |
| Emergency / Parking | 1.1 | 1.1 | - | |

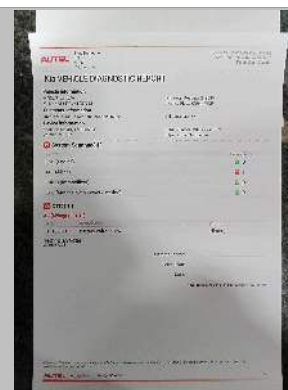
Diagnostic test

| No | System | Code | Description | Status |
|---|---|---|---|---|
| 1 | AIRBAG | B1102:00 | BATTERY VOLTAGE LOW | |

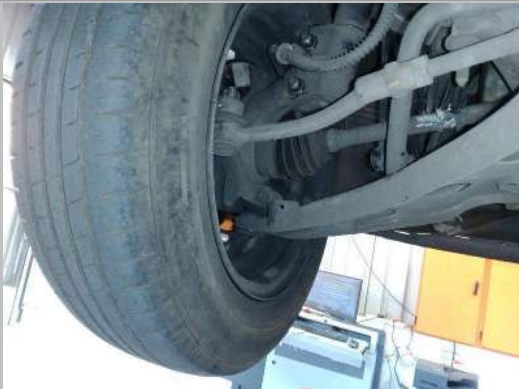
LF TYRE TREAD

| | Size | Load/Speed Index | Manufacture | Model | Type* | Production Date | Tread Depth (mm) |
|---|---|---|---|---|---|---|---|
| Front Left | 165/70R14 | 81T | Duragrip | HD918 | V | 0124 | 2 mm |

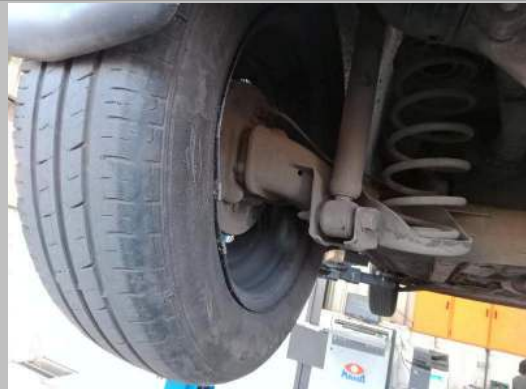
LR TYRE TREAD

| Damage | Repair Way |
|---|---|
| Tyre Rear Left Smooth | Replace |

| | Size | Load/Speed Index | Manufacture | Model | Type* | Production Date | Tread Depth (mm) |
|---|---|---|---|---|---|---|---|
| Rear Left | 175/65R14 | 82H | Powertrac | Adams | V | 3124 | 0 mm |

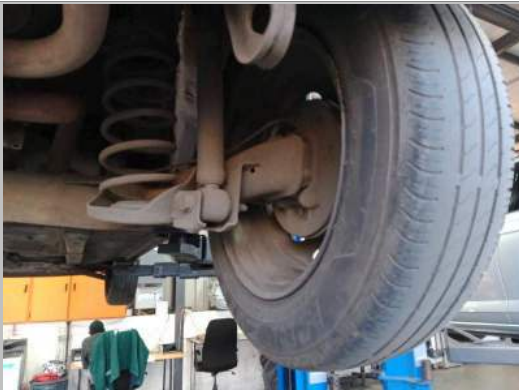
RR TYRE TREAD

| | Size | Load/Speed Index | Manufacture | Model | Type* | Production Date | Tread Depth (mm) |
|---|---|---|---|---|---|---|---|
| Rear Right | 165/70R14 | 81S | MRF | ZVTS | V | 4622 | 1 mm |

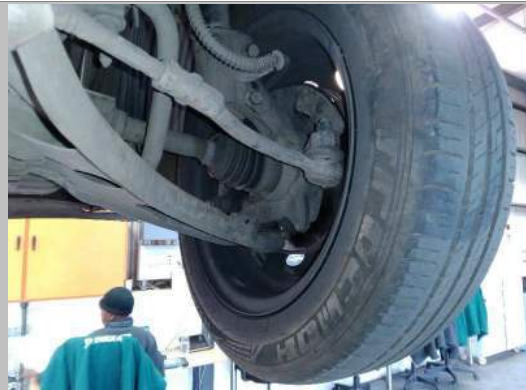
RF TYRE TREAD

| | Size | Load/Speed Index | Manufacture | Model | Type* | Production Date | Tread Depth (mm) |
|---|---|---|---|---|---|---|---|
| Front Right | 165/60R14 | 75H | Tracmak | Privilo | V | 2153 | 2 mm |

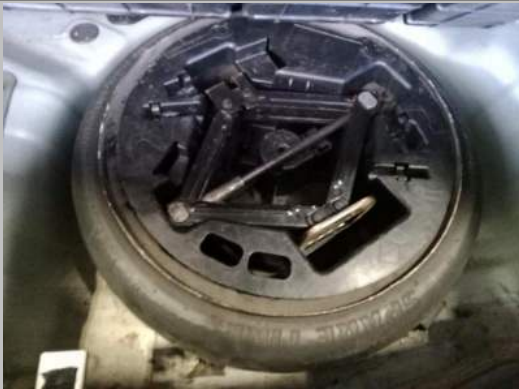
Sparewheel

| Damage | Repair Way |
|---|---|
| Spare Tyre Smooth | Replace |
