MFC Auction House  
M57 Pretoria Rd, Glenmarais, KEMPTON PARK  
Gauteng

Vehicle Type	PASSENGER VEHICLE	Registered Owner	MFC AUCTION HOUSE
Manufacturer	KIA	Registration Number	JC61SXGP
Model	RIO	Register Number	
VIN	KNADB512LK6324007	Date Of First Licensing	
Engine Number		Last COR	
Doors	5	License Expiry Date	31/08/2024
Color	RED	Power / Displacement	
Year Model		Paint Finish	M - METALLIC
Km Reading	152,795 KM	Fuel	PETROL
Cab / Body Type	HATCHBACK	Transmission	MANUAL

## CONDITION REPORT

Report No: 2016265337

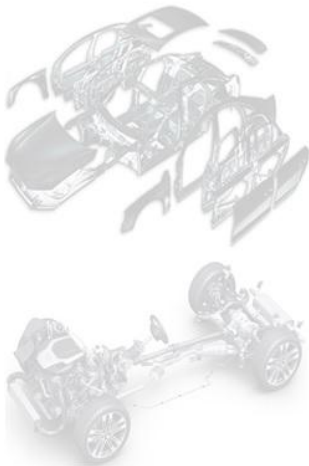
Damage	Repair Way
Side Mirror Left Damaged	Replace
Windscreen Cracked	Replace

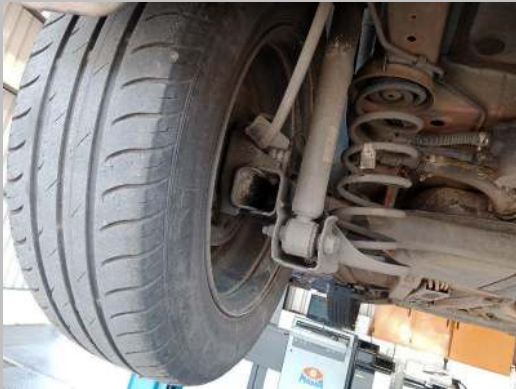
LR TYRE TREAD

Size	Load/Speed Index	Manufacture	Model	Type*	Production Date	Tread Depth (mm)
Front Left	185/65R15	92H	Dunlop	Sport	V	3321	3 mm
Front Right	185/65R15	92H	Dunlop	Sport	V	3321	5 mm
Rear Left	185/65R15	88H	Nexen	Nblue	V	1619	5 mm
Rear Right	185/65R15	88H	Nexen	Nblue	V	1619	6 mm
Spare	185/65R15	88T	Goodyear	GT3	V	0000	5 mm
