## CONDITION REPORT

Report No: 2016878508

| Manufacturer | KIA | Registration Number | KTF717NW |
| Model | RIO | Register Number | |

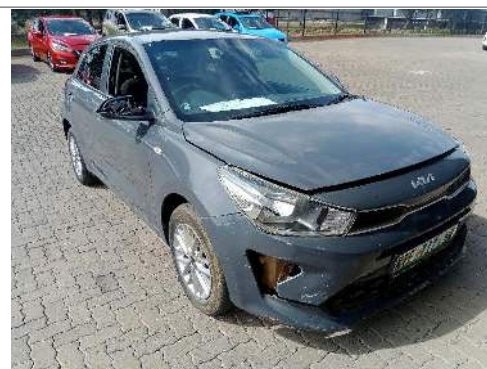
FRONT RIGHT CORNER

Body • Exterior: Minor dents and scratches and stone chips to some body panels. Signs of repair work done to somebody panels. Poor alignment to somebody panels. Vehicle body in poor condition. Repair work done to vehicle below standard.

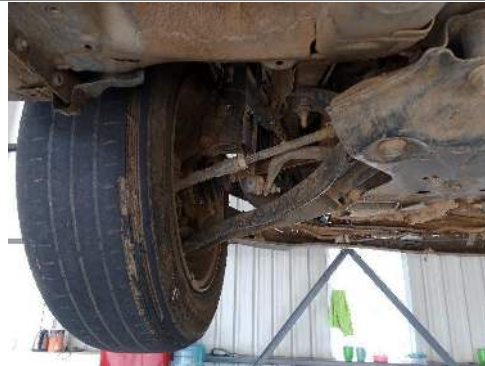
LF TYRE TREAD

| Damage | Repair Way |
|---|---|
| Tyre Front Left Worn | Replace |

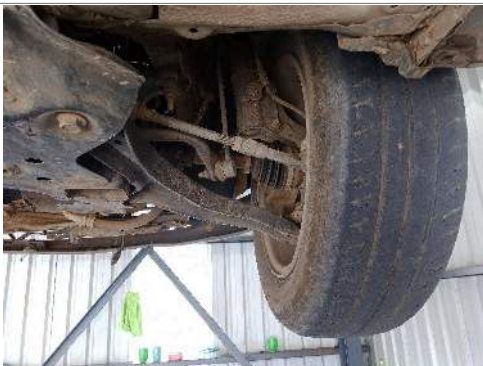
RF TYRE TREAD

| Damage | Repair Way |
|---|---|
| Tyre Front Right Worn | Replace |

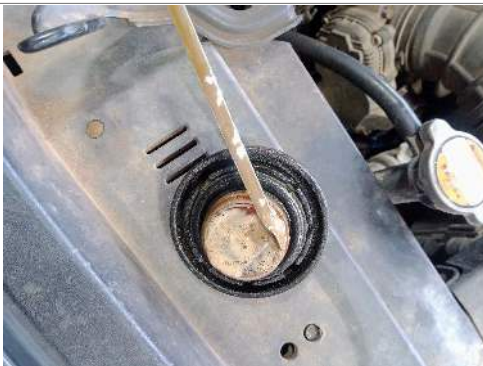
Oil cap and dipstick.

General Comments: ACCORDING TO THE AGE AND MILEAGE OF THE VEHICLE, NORMAL WEAR AND TEAR MARKS ARE VISIBLE ON THE INTERIOR, EXTERIOR, ELECTRICAL AND MECHANICAL PARTS. 10 DTC'S AT TIME OF TESTING SEE DTC REPORT. Engine Compartment: foreign substance on oil filler cap. aircon condenser damaged. Sump damaged.
