MFC Auction House  
M57 Pretoria Rd, Glenmarais, KEMPTON PARK  
Gauteng

Vehicle Type	PASSENGER VEHICLE	Registered Owner	MFC AUCTION HOUSE
Manufacturer	KIA	Registration Number	FJ16RFGP
Model	RIO	Register Number	
VIN	KNADN511LG6763118	Date Of First Licensing	
Engine Number		Last COR	
Doors	5	License Expiry Date	31/10/2024
Color	RED	Power / Displacement	
Year Model		Paint Finish	M - METALLIC
Km Reading	121,880 KM	Fuel	PETROL
Cab / Body Type	HATCHBACK	Transmission	MANUAL

## CONDITION REPORT

Report No: 2016256681

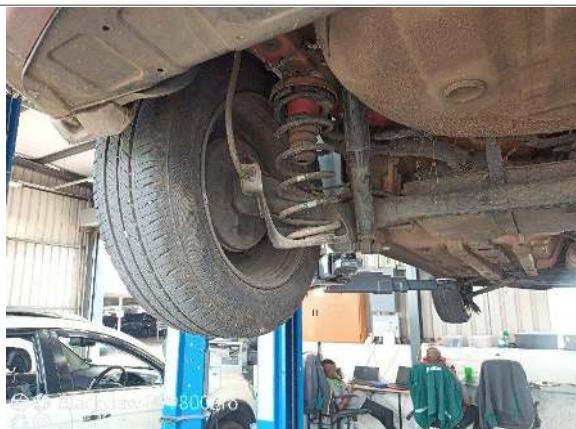
LR TYRE TREAD

Size	Load/Speed Index	Manufacture	Model	Type*	Production Date	Tread Depth (mm)
Front Left	185/65R15	88H	Invovic	EI601	V	2518	2 mm
Front Right	185/65R15	88H	Goodride	Radial	V	1622	3 mm
Rear Left	185/65R15	88H	Firestone	Touring	V	5021	3 mm
Rear Right	185/65R15	88H	Kumho	Solus	V	4115	3 mm

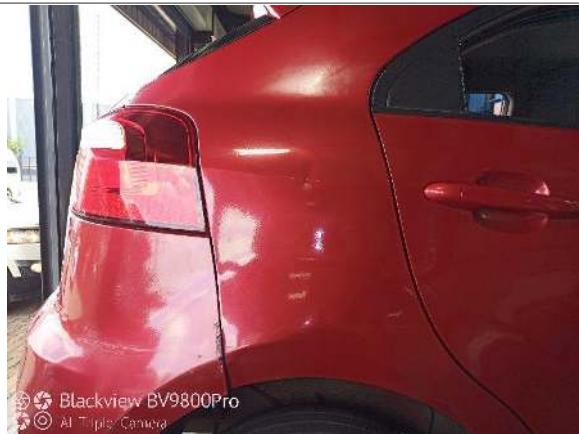
Damage	Repair Way
Headlight Right Damaged	Replace
Seat Front Left Torn / Cut	Repair
Side Mirror Left Paintwork • Scratched	Repair
Side Mirror Right Paintwork • Scratched	Repair
Front Bumper Damaged	Repair
A • Pillar Right Paintwork • Discoloured	Repair
Front Fender Left Dented	Repair
Front Fender Right Paintwork • Scratched	Repair
Rear Fender Left Paintwork • Scratched	Repair
Rear Fender Right Dented	Repair
Door Front Left Paintwork • Scratched	Repair
Door Front Right Dented	Repair
Door Rear Left Dented	Repair
Door Rear Right Paintwork • Scratched	Repair
Boot Lid / Hatch door Paintwork • Scratched	Repair
Rear bumper Damaged	Repair
Service Brake Performance Front Axle Left / Right Difference out of legal range	Repair
Bolt(s) / Nut(s) Front Wheel Left Damaged	Repair
Bolt(s) / Nut(s) Front Wheel Right Missing	Replace
CV Joint(s) Boot(s) Front Left (inner/outer) Defective	Repair
CV Joint(s) Boot(s) Front Right (inner/outer) Defective	Repair

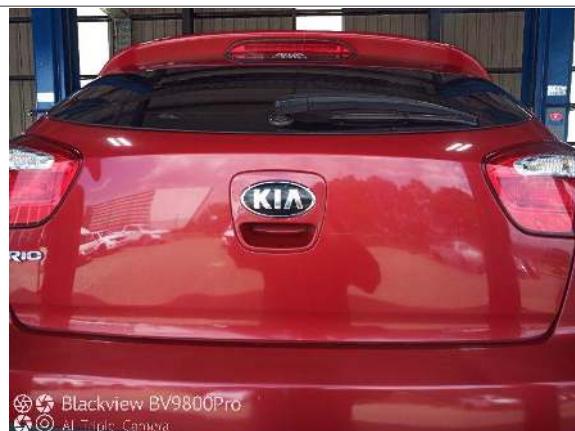
Boot Lid / Hatch door

Boot not opening cannot see spare wheel	Repair
Boot release button missing	Replace
Both front fender liner damage	Replace
Airbag light on	Repair
