CONDITION REPORT

Report No:
2016963143
DATE
30/07/2025

Vehicle Type	PASSENGER VEHICLE	Registered Owner	MFC
Manufacturer	KIA	Registration Number	JJX551MP
Model	RIO 1.4 TEC 5-DR [2015-2018]	Register Number	
VIN	KNADN512LG6767023	Date Of First Licensing	
Engine Number		Last COR	
Doors	5	License Expiry Date	31/10/2020
Color	SILVER	Power / Displacement	
Year Model	2017	Paint Finish	M - METALLIC
Km Reading	59,208 KM	Fuel	PETROL
Cab / Body Type	HATCHBACK	Transmission	MANUAL

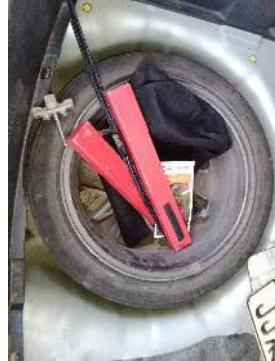
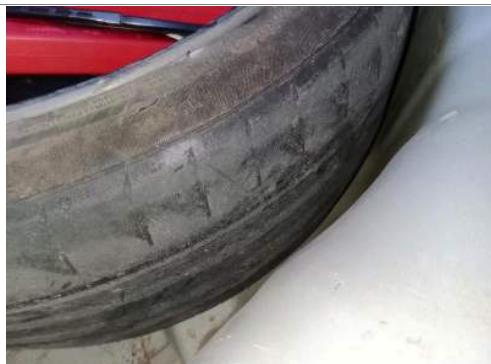
Spare Tyre

Size	Load/Speed Index	Manufacture	Model	Type*	Production Date	Tread Depth (mm)
Front Left	205/45ZR17	88W	Autogrip	Grip200	V	3618	1 mm
Front Right	205/45ZR17	88W	Autogrip	Grip200	V	3618	0 mm
Rear Left	205/45ZR17	88W	Continental	ContiSport	V	3215	0 mm
Rear Right	205/45ZR17	84W	Dunlop	SP Sport	V	1117	0 mm
Spare	205/45R17	88W	Continental	ContiSport	V	0000	0 mm

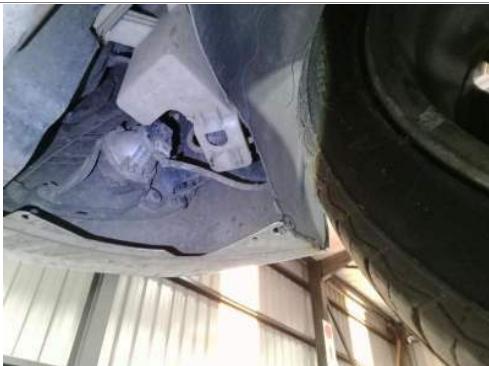
Damage	Repair Way
Seat Belt Rear Left Defective	Repair
Hood Lining Dirty	Repair
Side Mirror Left Broken	Replace
Side Mirror Right Broken	Replace
Front Bumper Damaged	Repair
Bonnet Dented	Repair
Front Fender Left Paintwork • Scratched	Repair
Front Fender Right Paintwork • Scratched	Repair
Rear Fender Right Paintwork • Scratched	Repair
Front Fender Right / Inner Tray Broken	Replace
Door Front Left Paintwork • Scratched	Repair
Door Rear Left Paintwork • Scratched	Repair
Door Rear Right Paintwork • Scratched	Repair
Roof Dented	Repair
Sealing Sun Roof Worn	Repair
Windscreen Chipped	Repair
Tyre Front Right Torn / Cut	Replace
Tyre Rear Left Damaged	Replace
Tyre Rear Right Damaged	Replace
Spare Tyre Worn	Replace
Rim Front Left Dented	Repair
Rim Rear Right Scratched	Repair
Sub Frame Scratched	Repair
Fuel Tank Deformed	Repair
