MFC Auction House  
M57 Pretoria Rd, Glenmarais, KEMPTON PARK  
Gauteng

| Vehicle Type | PASSENGER VEHICLE | Registered Owner | MFC AUCTION HOUSE |

## CONDITION REPORT

Report No: 2016311715

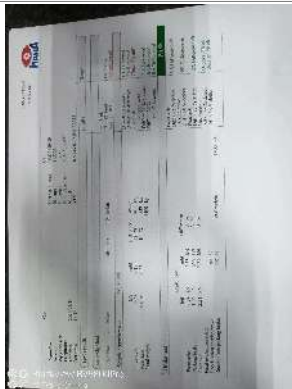
SHOCK & BRAKE REPORT

| | Left | Right | | |
|---|---|---|---|---|
| Front | 3.2 | 3.3 | - | |
| Rear | 2.2 | 2.2 | - | |
| Emergency / Parking | 1.9 | 1.9 | - | |

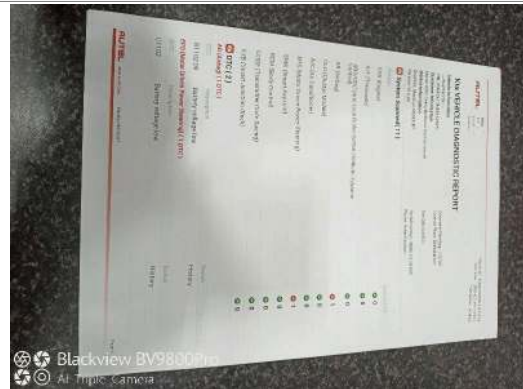
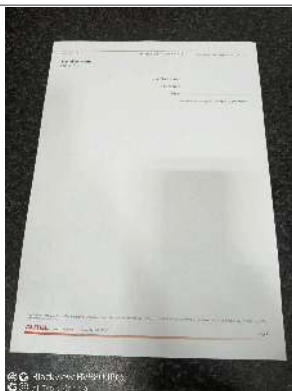
DIAGNOSTIC REPORT PAGE 1

During the diagnostic no active error messages were detected. (See also attached Diagnostic Report. For more information regarding the Fault Codes (DTC) and the recommended rectifications please contact the workshops of the vehicle manufacture).
