CONDITION REPORT

Report No: 2016270741

DATE
16/02/2024

MFC Auction House
M57 Pretoria Rd, Glenmarais, KEMPTON PARK
Gauteng

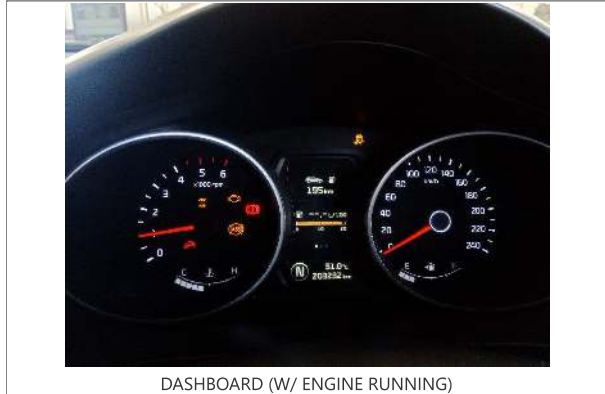
DASHBOARD (W/ ENGINE RUNNING)

Damage	Repair Way
Engine Oil Leak	Repair
Switch Electrical Window Winder rear left Defective	Repair
Switch Electrical Window Winder rear right Defective	Repair
Interior Lights Defective	Replace
Fog Light Front Left Defective	Replace
Fog Light Rear Right Cracked	Replace
Wiring connections Defective	Repair
Front Bumper Paintwork • Scratched	Repair
Boot Lid / Hatch door Residual Traces of Repair	Repair
Caliper 1. Axle right Leak	Repair
Stabilizer Mounting Front Left Damaged	Replace
Control Arm Bush(es) Front Axle Right Cracked	Replace
Ball Joint(s) Front Axle Right Damaged	Replace
Bolt(s) / Nut(s) Front Wheel Left Missing	Replace
Bolt(s) / Nut(s) Front Wheel Right Missing	Replace
Prop Shaft Damaged	Replace
CV Joint(s) Front Left (inner/outer) Damaged	Repair
CV Joint(s) Front Right (inner/outer) Damaged	Repair
Engine Smoke Excessive	Repair
Gear Selections Malfunction	Repair
Multiple warning signs illuminated.	Repair.

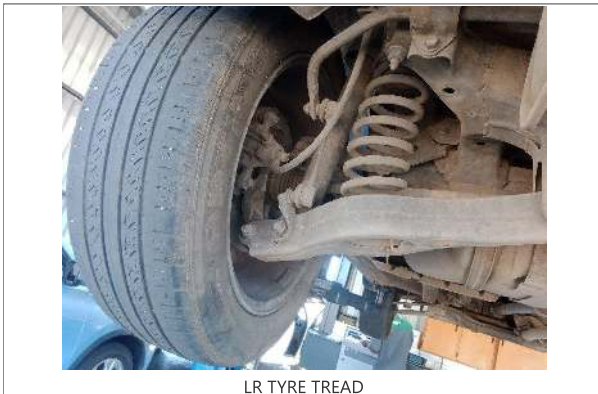
LR TYRE TREAD

Size	Load/Speed Index	Manufacture	Model	Type*	Production Date	Tread Depth (mm)
Front Left	225/55R18	98V	General	Grabber	V	1020	1 mm
Front Right	225/55R18	98V	General	Grabber	V	1020	1 mm
Rear Left	225/55R18	98H	Hankook	Optimo	V	3019	2 mm
Rear Right	225/55R18	98H	Hankook	Optimo	V	3019	2 mm
Spare	T155/90D16	110M	Maxxis	Temporary	V	///////	5 mm

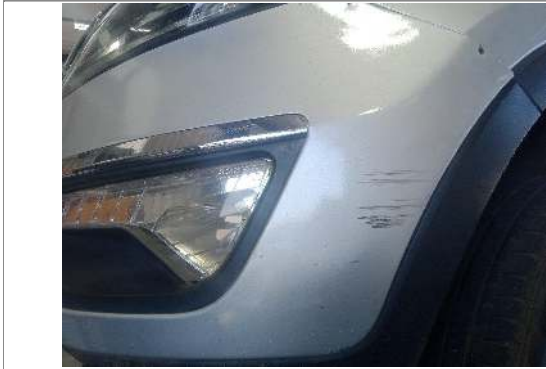
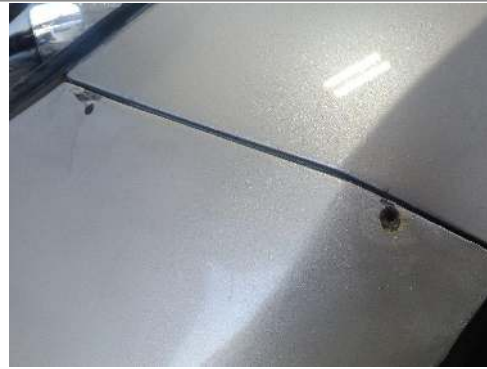
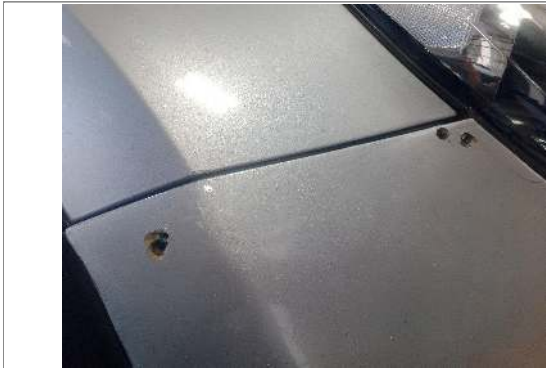
Front Bumper

Signs of spray work done on some body panels.	
Some body panels misaligned.	
Automatic gear selection faulty.	
Minor dents scratches stone chips	on some body panels
Have to press the shift lock release button	to release button to select gears.
