MFC Auction House
M57 Pretoria Rd, Glenmarais, KEMPTON PARK
Gauteng

DEKRA MFC
M57 Pretoria Rd - 1619
KEMPTON PARK - GT
08610 33572

VEHICLE INSPECTION

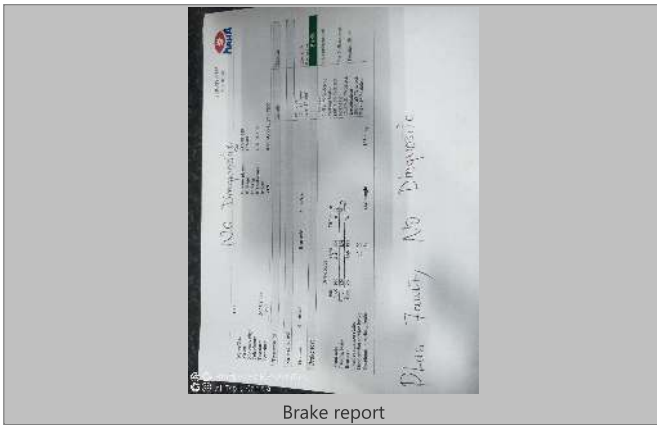
Brake report

Left	Right	Axle Weight [KG]	Deceleration [m/s ²]
	Braking Force [KN]	Braking Force [KN]		
Front	3.6	4.4	-	
Rear	0.6	0.6	-	
Emergency / Parking	0	0	-

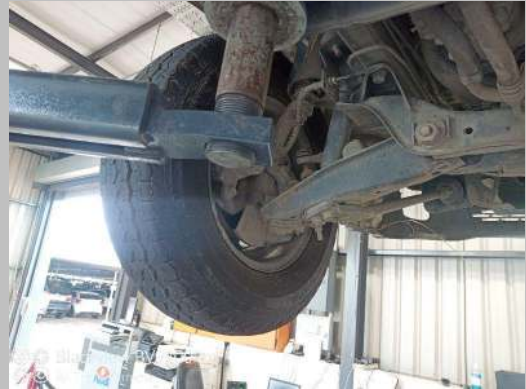
LF TYRE TREAD

Size	Load/Speed Index	Manufacture	Model	Type*	Production Date	Tread Depth (mm)
Front Left	195R14	106/104S	Dunlop	Radial	V	3323	3 mm
Front Right	195R14	106/104S	Dunlop	Sp van01	V	0922	2 mm
Rear Left In	155R12	88/86R	Dunlop	Sp van01	V	////	3 mm
Rear Left	155/80R12	77T	Road king	Argos	V	0123	3 mm
Rear Right In	155R12	88/86R	Dunlop	Sp van01	V	////	3 mm
Rear Right	155R12	88/86R	Dunlop	Sp van01	V	0822	3 mm

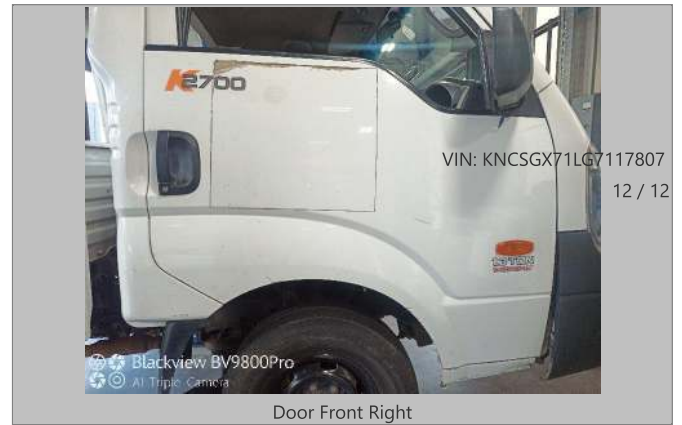
Door Front Right

Body • Exterior: Vehicle got some scratches, stone chips and dents on some body panels

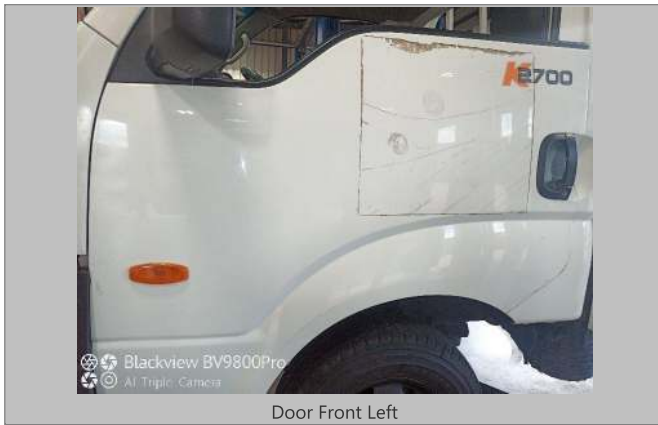
Damage	Repair Way
Tail Light Left Damaged	Replace
Tail Light Right Damaged	Replace
Seat Front Left Dirty	Repair
Seat Front Right Damaged	Repair
Door Panel Front Left Damaged	Repair
Dash Padding Defective	Replace
Gear Lever Dust Boot Excessive Wear & Tear	Repair
Side Mirror Right Damaged	Repair
Front Bumper Damaged	Replace
Bonnet Paintwork • Scratched	Repair
Door Front Left Paintwork • Scratched	Repair
Door Front Right Paintwork • Scratched	Repair
Tailgate Paintwork • Scratched	Repair
Rear bumper Dented	Repair
Fuel Cap Missing	Replace
Load Body Dented	Repair
Back Window Damaged	Replace
Parking Brake Performance Left / Right Difference out of legal range	Repair
Ball Joint(s) Front Axle Left Damaged	Replace
Ball Joint(s) Front Axle Right Damaged	Replace
Gearbox Oil Leak	Repair
No diagnostic plug malfunction	Repair
Key damage	Repair
Parking brake light on	Repair
