## CONDITION REPORT

Report No:  
2016919667  
DATE  
20/06/2025

| Manufacturer | KIA | Registration Number | KL54ZKGP |
| Model | K2700 | Register Number | |

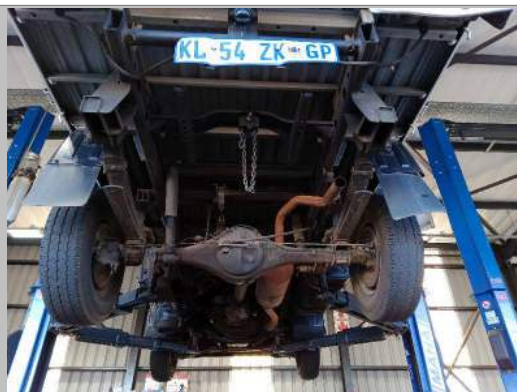
### Front chassis

| Damage | Repair Way |
|---|---|
| Chassis Damaged | Repair |

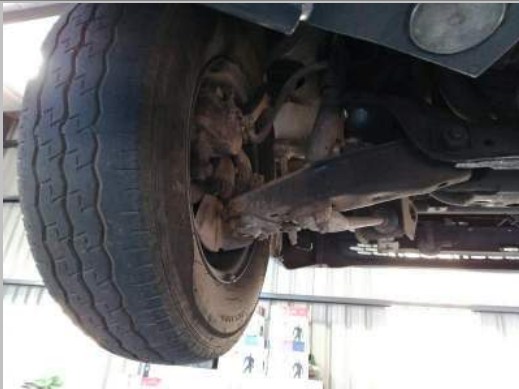
LF TYRE TREAD

| | Size | Load/Speed Index | Manufacture | Model | Type* | Production Date | Tread Depth (mm) |
|---|---|---|---|---|---|---|---|
| Front Left | 195R14C | 106S | Dunlop | SPLT-11 | V | 2624 | 2 mm |

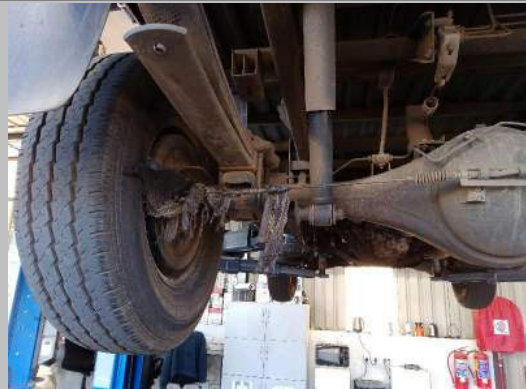
LR TYRE TREAD

| | Size | Load/Speed Index | Manufacture | Model | Type* | Production Date | Tread Depth (mm) |
|---|---|---|---|---|---|---|---|
| Rear Left | 195R14C | 106R | Fullrun | Frun-Five | V | 0424 | 4 mm |

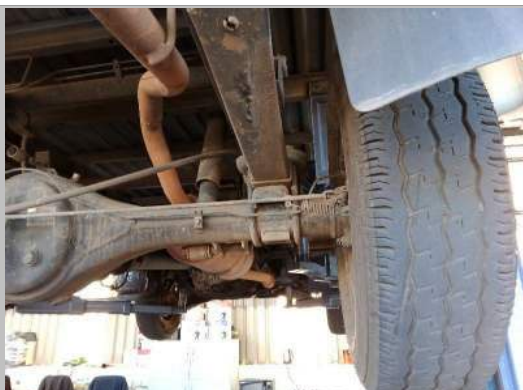
RR TYRE TREAD

| | Size | Load/Speed Index | Manufacture | Model | Type* | Production Date | Tread Depth (mm) |
|---|---|---|---|---|---|---|---|
| Rear Right | 195R14C | 106S | Dunlop | Sp-Sport | V | 2524 | 4 mm |

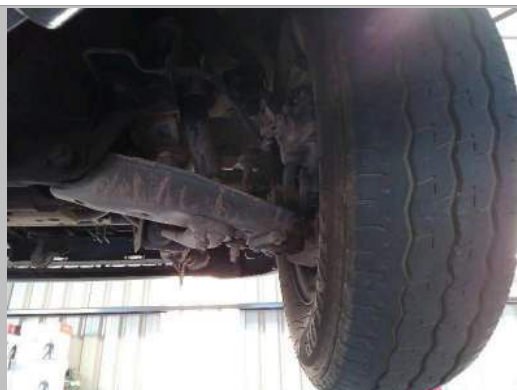
RF TYRE TREAD

| | Size | Load/Speed Index | Manufacture | Model | Type* | Production Date | Tread Depth (mm) |
|---|---|---|---|---|---|---|---|
| Front Right | 195R14C | 106S | Dunlop | Sp-Sport | V | 2824 | 2 mm |
