CONDITION REPORT

Report No: 2016846222

MFC Auction House
M57 Pretoria Rd, Glenmarais, KEMPTON PARK
Gauteng

Vehicle Type	LIGHT LOAD VEHICLE	Registered Owner	
Manufacturer	GWM	Registration Number	LD94FCGP
Model	STEED 2.0 S DSL PU [2022-ON]	Register Number	
VIN	LGWCB374NB670649	Date Of First Licensing	
Engine Number		Last COR	
Doors	2	License Expiry Date	30/04/2025
Color	WHITE	Power / Displacement	
Year Model	2023	Paint Finish	C - COMMON
Km Reading	46,235 KM	Fuel	DIESEL
Cab / Body Type	SINGLE CAB	Transmission	MANUAL

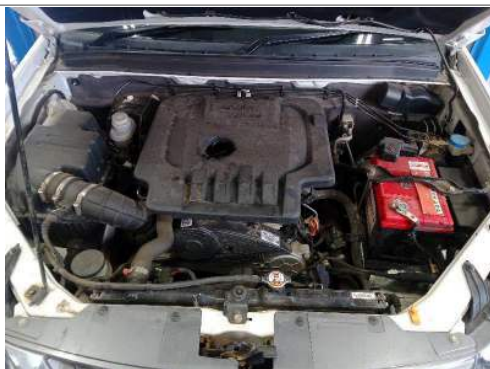
ENGINE 1

Engine number – not possible to verify engine number (not visible without dismantling)
