CONDITION REPORT

Report No:  
2017299335  
DATE  
16/09/2026

| Manufacturer | GWM | Registration Number | LP86NZGP |
| Model | P-SERIES 2.0TD CV DLX 6-SP DSL D-CAB PU [2020-2025] | Register Number | |

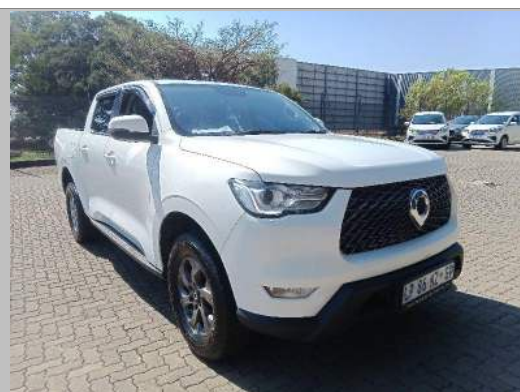
FRONT RIGHT CORNER

| Front Fender Right / Inner Tray Damaged | Repair |
| Door Front Right Dented | Repair |

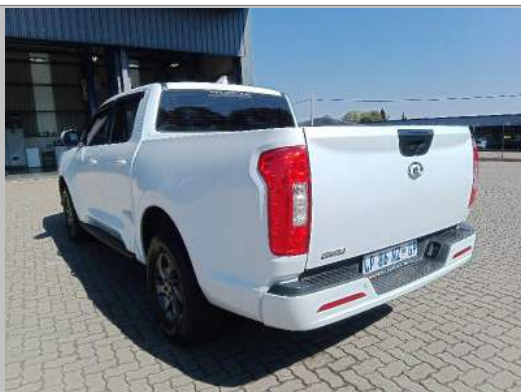
REAR LEFT CORNER

| Rear Fender Left Paintwork • Scratched | Repair |

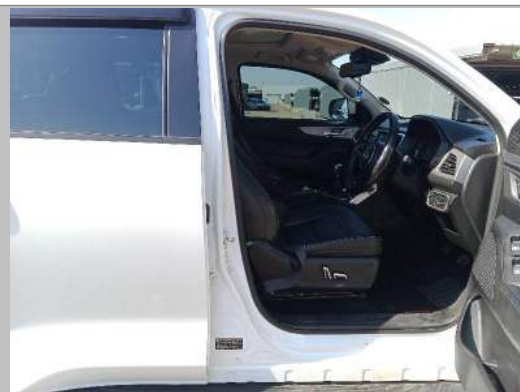
INTERIOR (FRONT DRIVER DOOR)

General Comments: ACCORDING TO THE AGE AND MILEAGE OF THE VEHICLE, NORMAL WEAR AND TEAR MARKS ARE VISIBLE ON THE INTERIOR, EXTERIOR, ELECTRICAL AND MECHANICAL PARTS. Interior: Vehicle interior dirty and panels scratched. Gear lever worn.

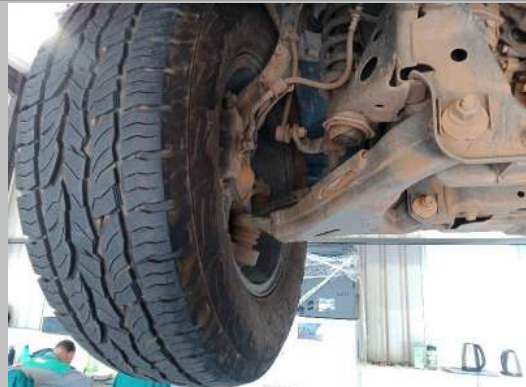
LF TYRE TREAD

| | Size | Load/Speed Index | Manufacture | Model | Type* | Production Date | Tread Depth (mm) |
|---|---|---|---|---|---|---|---|
| Front Left | 265/65 R17 | 112S | Dunlop | Grandtrek | V | 1225 | 3 mm |

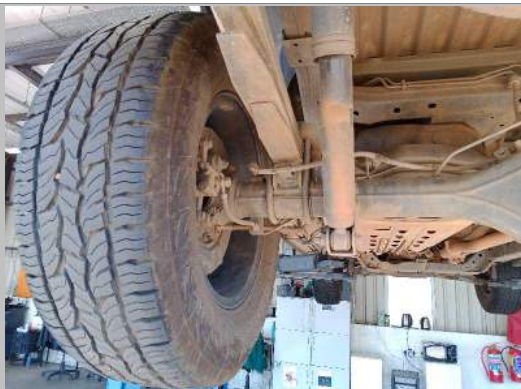
LR TYRE TREAD

| | Size | Load/Speed Index | Manufacture | Model | Type* | Production Date | Tread Depth (mm) |
|---|---|---|---|---|---|---|---|
| Rear Left | 265/65 R17 | 112S | Dunlop | Grandtrek | V | 1225 | 3 mm |

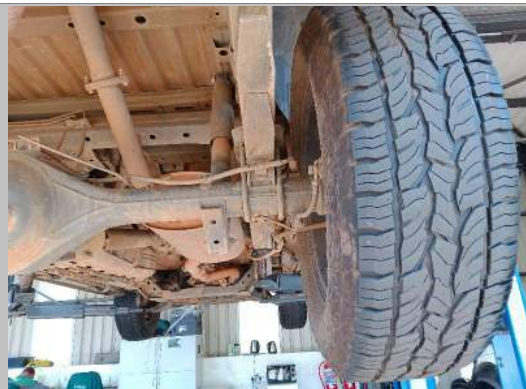
RR TYRE TREAD

| | Size | Load/Speed Index | Manufacture | Model | Type* | Production Date | Tread Depth (mm) |
|---|---|---|---|---|---|---|---|
| Rear Right | 265/65 R17 | 112S | Dunlop | Grandtrek | V | 1225 | 3 mm |

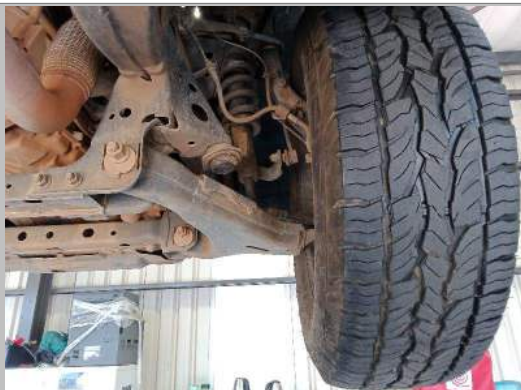
RF TYRE TREAD

| | Size | Load/Speed Index | Manufacture | Model | Type* | Production Date | Tread Depth (mm) |
|---|---|---|---|---|---|---|---|
| Front Right | 265/65 R17 | 112S | Dunlop | Grandtrek | V | 1225 | 3 mm |

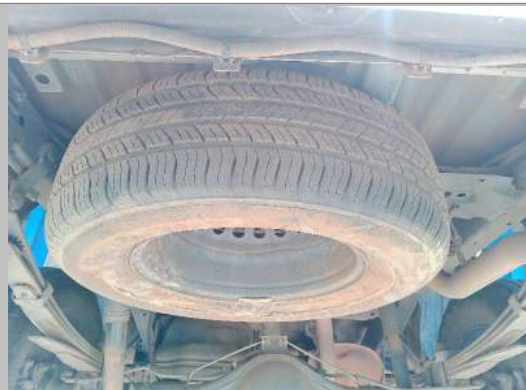
Spare Wheel

| | Size | Load/Speed Index | Manufacture | Model | Type* | Production Date | Tread Depth (mm) |
|---|---|---|---|---|---|---|---|
| Spare | 245/70 R17 | 110T | Choayang | SU318a | V | 0000 | 4 mm |

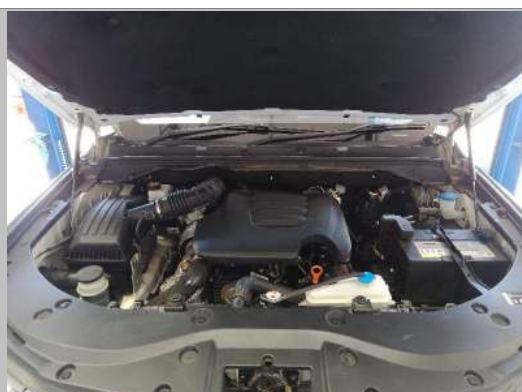
ENGINE 1

| Engine Oil Sweat | Repair |
