CONDITION REPORT

Report No:  
2017297345  
DATE  
11/09/2026

MFC Auction House  
M57 Pretoria Rd, Glenmarais, KEMPTON PARK  
Gauteng

| Manufacturer | HAVAL | Registration Number | MW99VGGP |

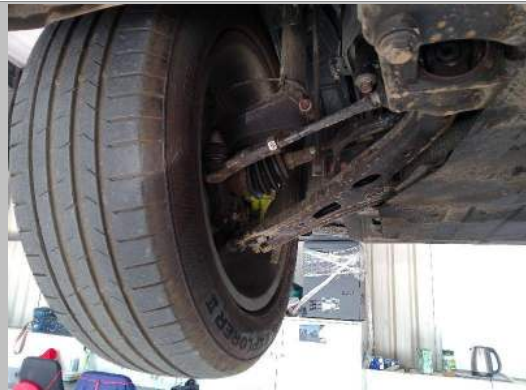
LF TYRE TREAD

| | Size | Load/Speed Index | Manufacture | Model | Type* | Production Date | Tread Depth (mm) |
|---|---|---|---|---|---|---|---|
| Front Left | 235/55Z R19 | 105W | Royalblack | Explorer | V | 4325 | 3 mm |

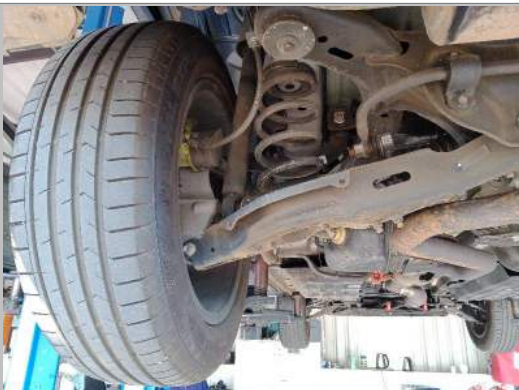
LR TYRE TREAD

| | Size | Load/Speed Index | Manufacture | Model | Type* | Production Date | Tread Depth (mm) |
|---|---|---|---|---|---|---|---|
| Rear Left | 235/55Z R19 | 105W | Royalblack | Explorer | V | 4325 | 4 mm |

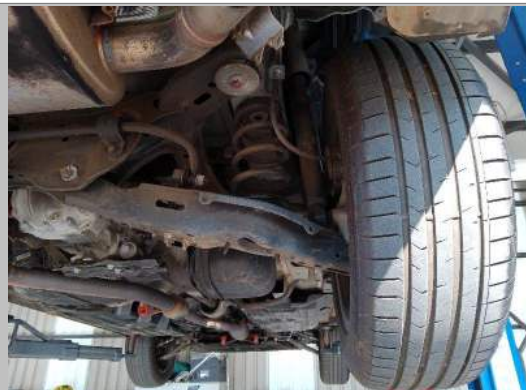
RR TYRE TREAD

| | Size | Load/Speed Index | Manufacture | Model | Type* | Production Date | Tread Depth (mm) |
|---|---|---|---|---|---|---|---|
| Rear Right | 235/55Z R19 | 105W | Royalblack | Explorer | V | 4325 | 4 mm |

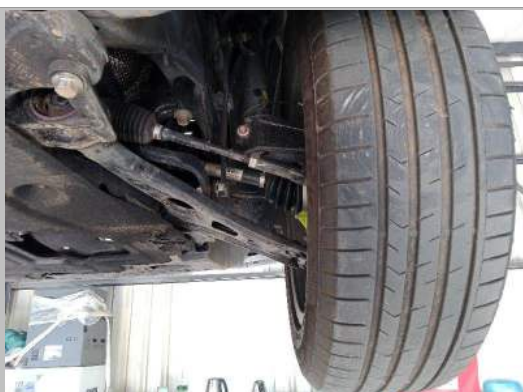
RF TYRE TREAD

| | Size | Load/Speed Index | Manufacture | Model | Type* | Production Date | Tread Depth (mm) |
|---|---|---|---|---|---|---|---|
| Front Right | 235/55Z R19 | 105W | Royalblack | Explorer | V | 4325 | 3 mm |

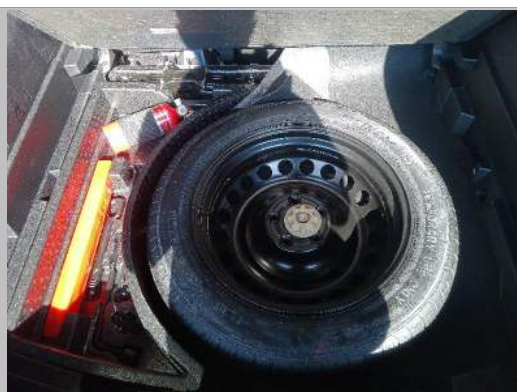
Spare Wheel and Accessories

| | Size | Load/Speed Index | Manufacture | Model | Type* | Production Date | Tread Depth (mm) |
|---|---|---|---|---|---|---|---|
| Spare | T135/90 R17 | 104M | Linglong | Temporary | V | 2523 | 3 mm |
