CONDITION REPORT

Report No:  
2017305017  
DATE  
29/09/2026

MFC Auction House  
M57 Pretoria Rd, Glenmarais, KEMPTON PARK  
Gauteng

| Manufacturer | HAVAL | Registration Number | MF27FPGP |

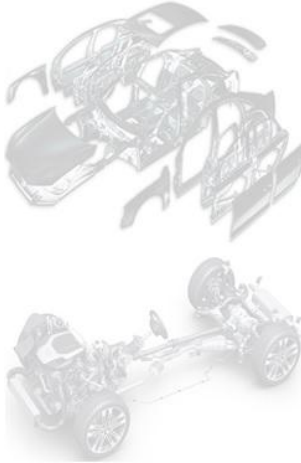
| | Damage | Repair Way |
|---|---|---|
| | Tail Light Left Damaged | Replace |
| | Front Bumper Damaged | Repair |
| | Rear Fender Left Damaged | Repair |
| | Door Rear Right Damaged | Repair |
| | Boot Lid / Hatch door Damaged | Repair |
| | Rear bumper Damaged | Repair |
| | Tyre pressure warning light illuminated | Repair |

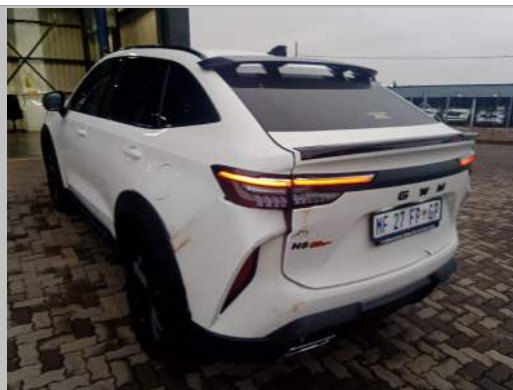
REAR LEFT CORNER

General Comments: ACCORDING TO THE AGE AND MILEAGE OF THE VEHICLE, NORMAL WEAR AND TEAR MARKS ARE VISIBLE ON THE INTERIOR, EXTERIOR, ELECTRICAL AND MECHANICAL PARTS. SIGNS OF REPAIR WORK DONE TO BODY PANELS. POOR ALIGNMENT TO SOMEBODY PANELS. SIGNS OF IMPACT DAMAGE TO REAR OF VEHICLE.
