MFC Auction House  
M57 Pretoria Rd, Glenmarais, KEMPTON PARK  
Gauteng

| Manufacturer | CHERY | Registration Number | KX90WDGP |

## CONDITION REPORT

Report No: 2016785801

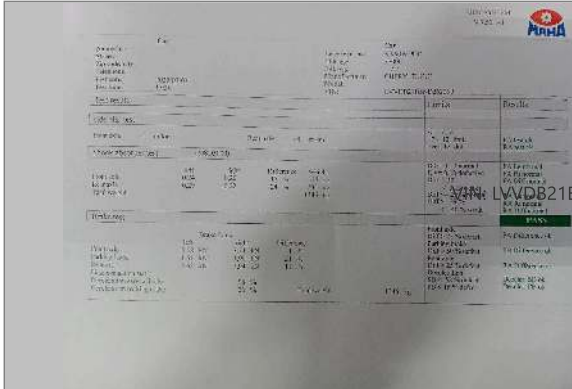
Brake and shock absorber report

| | Left | Right | | |
|---|---|---|---|---|
| Front | 3.68 | 3.71 | - | |
| Rear | 2.62 | 2.94 | - | |
| Emergency / Parking | 1.51 | 1.9 | - | |

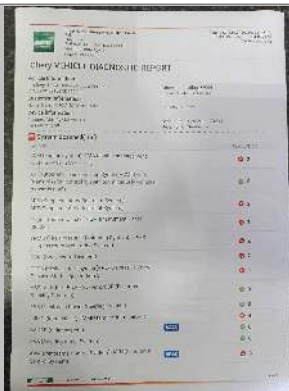
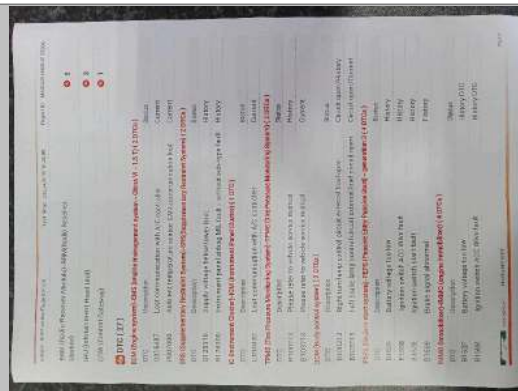
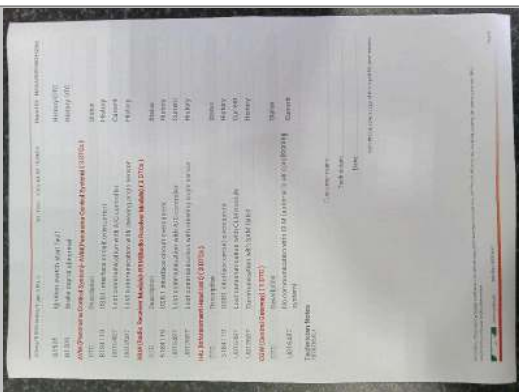
Diagnostic report page 1

| No | System | Code | Description | Status |
|---|---|---|---|---|
| 1 | ECM(ENGINE SYSTEM)-<br>EMS(ENGINE MANAGEMENT<br>SYSTEM | U016487 | LOST COMMUNICATION WITH A/C CONTROLLER | |

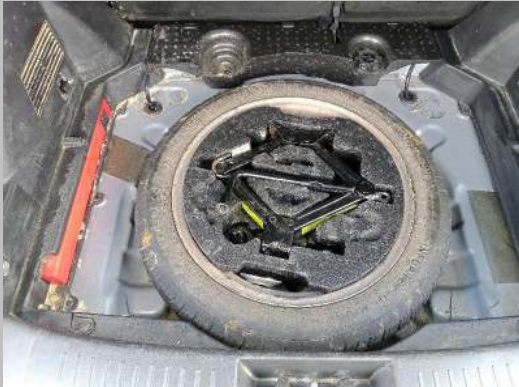
Spare wheel and Accessories

| | Size | Load/Speed Index | Manufacture | Model | Type* | Production Date | Tread Depth (mm) |
|---|---|---|---|---|---|---|---|
| Spare | T125/80 R17 | 99M | Linglong | Temporary | V | 2822 | 2 mm |

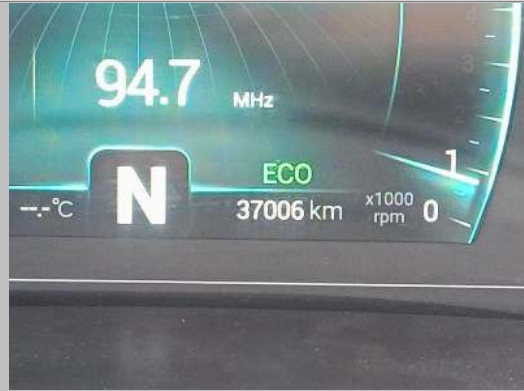
ODOMETER

| Km Reading | 37,006 KM | Fuel | PETROL |

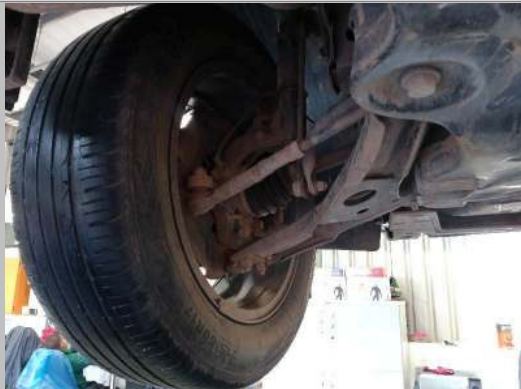
LF TYRE TREAD

| | Size | Load/Speed Index | Manufacture | Model | Type* | Production Date | Tread Depth (mm) |
|---|---|---|---|---|---|---|---|
| Front Left | 215/60 R17 | 96H | Citi | Comfort | V | 2122 | 3 mm |

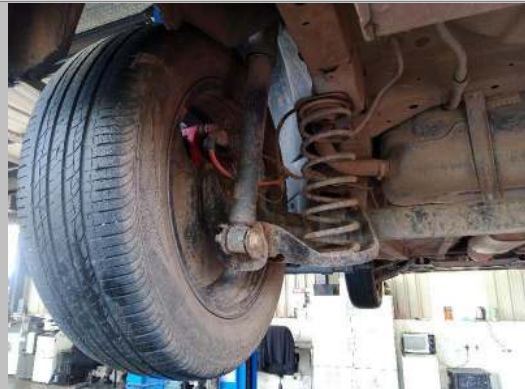
LR TYRE TREAD

| | Size | Load/Speed Index | Manufacture | Model | Type* | Production Date | Tread Depth (mm) |
|---|---|---|---|---|---|---|---|
| Rear Left | 215/60 R17 | 96H | Citi | Comfort | V | 2222 | 3 mm |

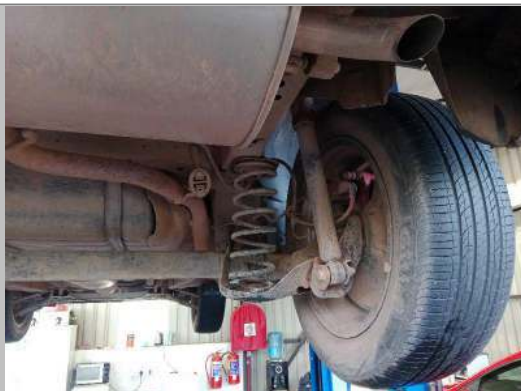
RR TYRE TREAD

| | Size | Load/Speed Index | Manufacture | Model | Type* | Production Date | Tread Depth (mm) |
|---|---|---|---|---|---|---|---|
| Rear Right | 215/60 R17 | 96H | Citi | Comfort | V | 2422 | 3 mm |

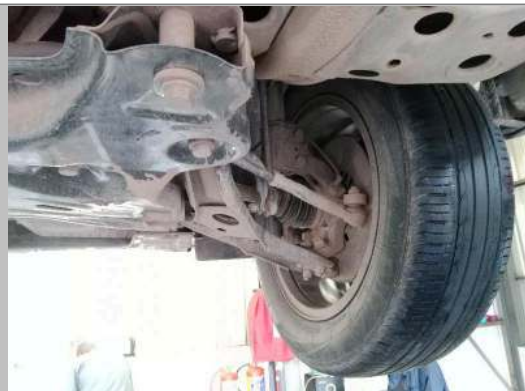
RF TYRE TREAD

| | Size | Load/Speed Index | Manufacture | Model | Type* | Production Date | Tread Depth (mm) |
|---|---|---|---|---|---|---|---|
| Front Right | 215/60 R17 | 96H | Citi | Comfort | V | 2422 | 3 mm |
