MFC Auction House  
M57 Pretoria Rd, Glenmarais, KEMPTON PARK  
Gauteng

DEKRA MFC  
M57 Pretoria Rd - 1619  
KEMPTON PARK - GT  
08610 33572

## VEHICLE INSPECTION

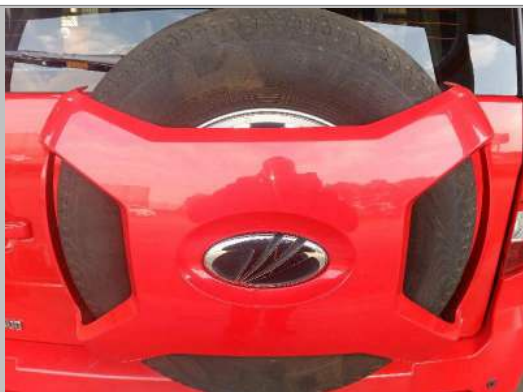
Spare wheel

| Damage | Repair Way |
|---|---|
| Spare Tyre Smooth | Replace |

| | Size | Load/Speed Index | Manufacture | Model | Type* | Production Date | Tread Depth (mm) |
|---|---|---|---|---|---|---|---|
| Spare | 215R15 | 109/107S | Autogrip | Blazer | V | 1417 | 0 mm |

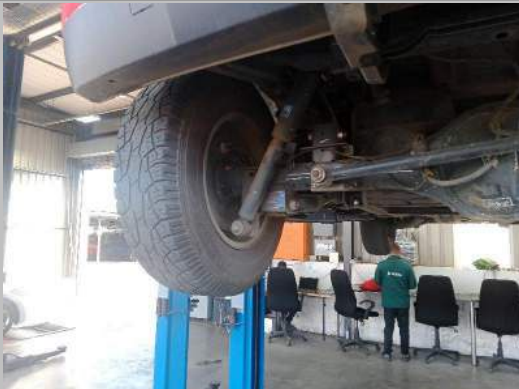
LR TYRE TREAD

| | Size | Load/Speed Index | Manufacture | Model | Type* | Production Date | Tread Depth (mm) |
|---|---|---|---|---|---|---|---|
| Rear Left | 215/75R15 | 100S | Hifly | All terrain | V | 3321 | 5 mm |

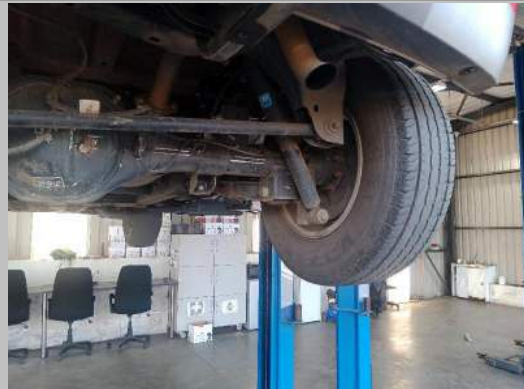
RR TYRE TREAD

| | Size | Load/Speed Index | Manufacture | Model | Type* | Production Date | Tread Depth (mm) |
|---|---|---|---|---|---|---|---|
| Rear Right | 215/75R15 | 100S | Ceat | Czar h/t | V | 4519 | 4 mm |
