MFC Auction House
M57 Pretoria Rd, Glenmarais, KEMPTON PARK
Gauteng

DEKRA MFC
M57 Pretoria Rd - 1619
KEMPTON PARK - GT
08610 33572

Vehicle Data

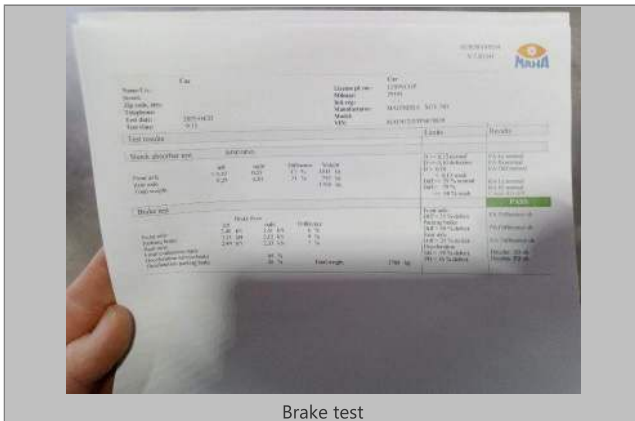
Brake test

Left	Right	Axle Weight [KG]	Deceleration [m/s ²]
	Braking Force [KN]	Braking Force [KN]		
Front	3.4	3.61	-	
Rear	2.49	2.33	-	
Emergency / Parking	2.33	2.12	-

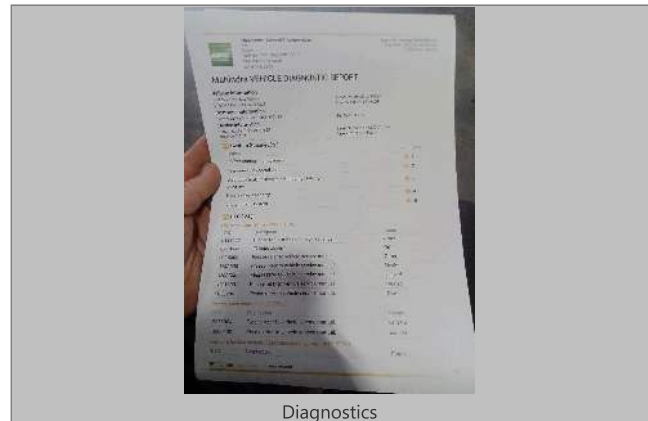
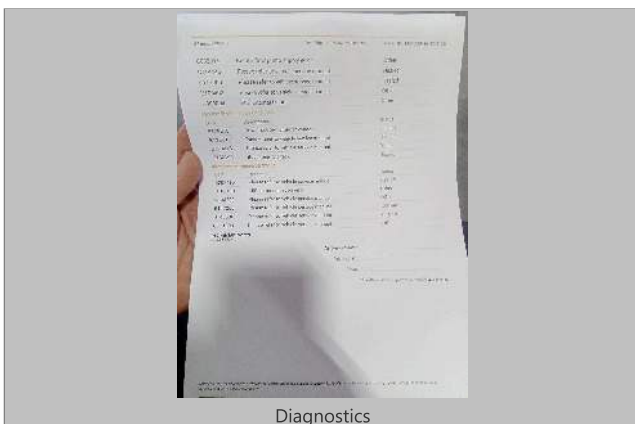
Diagnostics

No	System	Code	Description	Status
1	ENGINE MANAGEMENT SYSTEM	U113200	PLEASE REFER TO VEHICLE SERVICE MANUAL

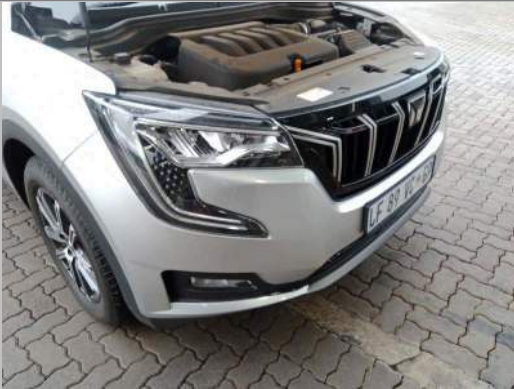
Damage	Repair Way
Engine Management Lights Set	Repair
Front Bumper Damaged	Repair
Bonnet Damaged	Repair
Front Fender Right Damaged	Repair
Door Front Left Damaged	Repair
Door Rear Left Damaged	Repair
Boot Lid / Hatch door Damaged	Repair
Rear bumper Damaged	Repair
Windscreen Damaged	Replace
Engine Smoke Excessive	Repair
