CONDITION REPORT

Report No:  
2017303943  
DATE  
28/09/2026

| Manufacturer | MAHINDRA | Registration Number | KLZ590NW |
| Model | KUV 100 NXT 1.2 K6+ MFALCON 5-DR [2018-2023] | Register Number | |

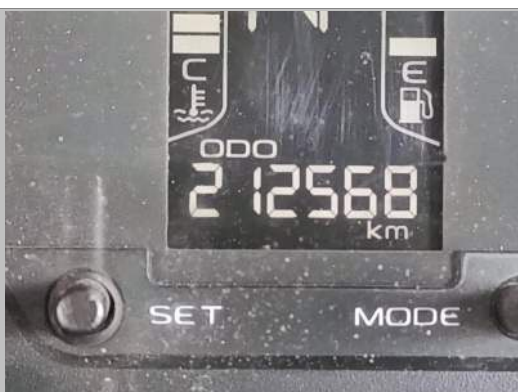
ODOMETER

| Km Reading | 212,568 KM | Transmission | MANUAL |

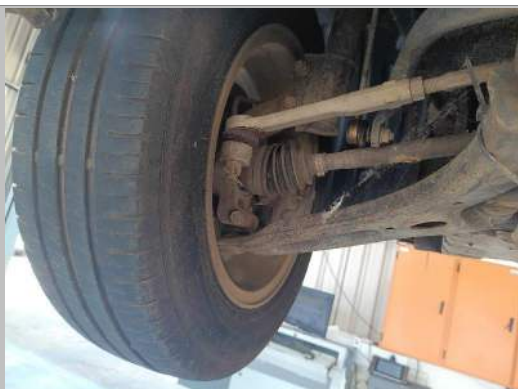
LF TYRE TREAD

| | Size | Load/Speed Index | Manufacture | Model | Type* | Production Date | Tread Depth (mm) |
|---|---|---|---|---|---|---|---|
| Front Left | 185/65R14 | 86H | Dunlop | Sport | V | 4723 | 4 mm |

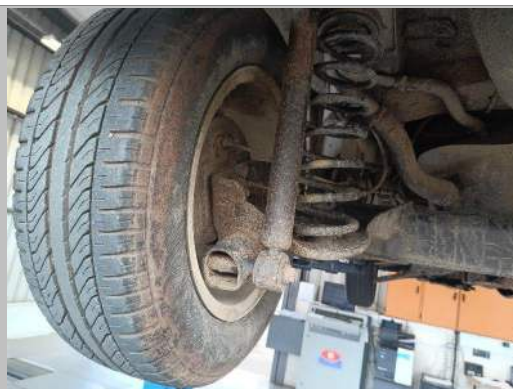
LR TYRE TREAD

| | Size | Load/Speed Index | Manufacture | Model | Type* | Production Date | Tread Depth (mm) |
|---|---|---|---|---|---|---|---|
| Rear Left | 185/65R14 | 86H | Dunlop | Sport | V | 4723 | 2 mm |

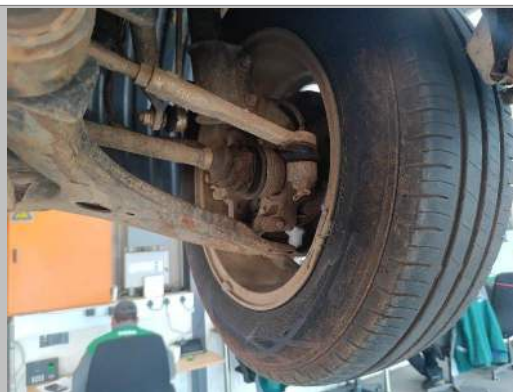
RF TYRE TREAD

| | Size | Load/Speed Index | Manufacture | Model | Type* | Production Date | Tread Depth (mm) |
|---|---|---|---|---|---|---|---|
| Front Right | 185/65R14 | 86H | Dunlop | Sport | V | 4723 | 3 mm |
