CONDITION REPORT

Report No: 2016867662

Vehicle Type	LIGHT LOAD VEHICLE	Registered Owner	
Manufacturer	MAHINDRA	Registration Number	KR07NMGP
Model	BOLERO	Register Number	
VIN	MA1ZP2TAKN2C85912	Date Of First Licensing	
Engine Number		Last COR	
Doors	2	License Expiry Date	31/03/2025
Color	WHITE	Power / Displacement	
Year Model		Paint Finish	TWO COAT UNI
Km Reading	36,644 KM	Fuel	DIESEL
Cab / Body Type	SINGLE CAB	Transmission	MANUAL

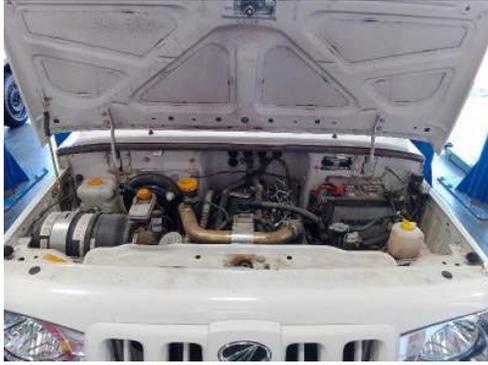
ENGINE 1

Damage	Repair Way
Engine Oil Leak	Repair
Front Bumper Paintwork • Scratched	Repair
Bonnet Paintwork • Chipmarks	Repair
C • Pillar Left Paintwork • Scratched	Repair
Rear Fender Left Dented	Repair
Door Front Left Paintwork • Scratched	Repair
Tailgate Paintwork • Scratched	Repair
Load Body Paintwork • Scratched	Repair
Windscreen Cracked	Replace
Mounting Rubber(s) Front Axle Left Cracked	Replace
Mounting Rubber(s) Front Axle Right Cracked	Replace
