## CONDITION REPORT

Report No:  
2017302486  
DATE  
23/09/2026

| Manufacturer | SUZUKI | Registration Number | LM86BFGP |
| Model | CIAZ | Register Number | |

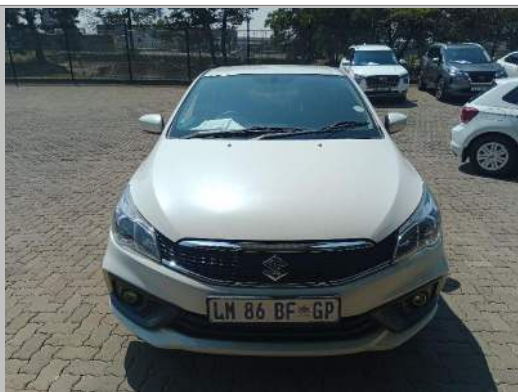
90 DEGREE FRONT

General Comments: 3 DTC'S AT TIME OF TESTING SEE DTC REPORT. ACCORDING TO THE AGE AND MILEAGE OF THE VEHICLE, NORMAL WEAR AND TEAR MARKS ARE VISIBLE ON THE INTERIOR, EXTERIOR, ELECTRICAL AND MECHANICAL PARTS. Body • Exterior: Minor dents and scratches and stone chips to body panels. Signs of repair work done to body panels. Poor alignment to somebody panels. Signs of impact damage to front of vehicle.

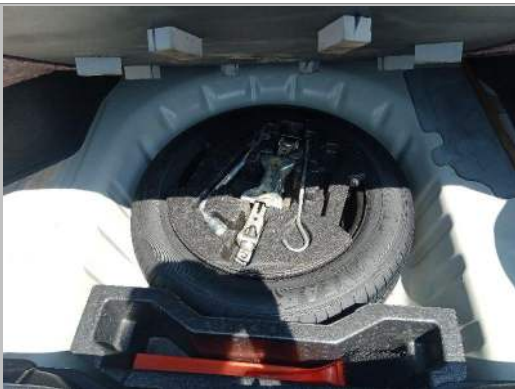
spare wheel

| | Size | Load/Speed Index | Manufacture | Model | Type* | Production Date | Tread Depth (mm) |
|---|---|---|---|---|---|---|---|
| Spare | 185/65R15 | 88H | Goodyear | Assurance | V | 0000 | 5 mm |

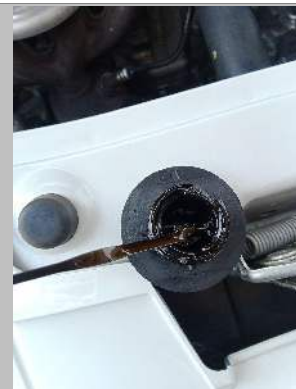
Oil cap and dipstick.

| Engine Oil Leak | Repair |

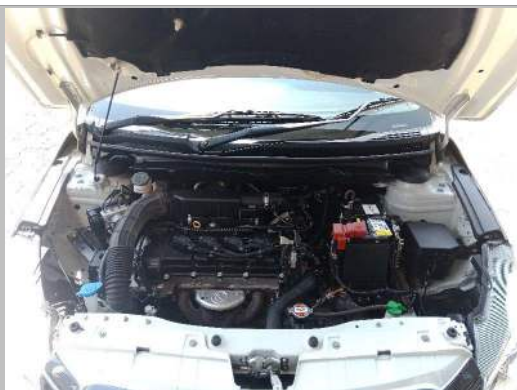
ENGINE 1

Engine number – not possible to verify engine number (not visible without dismantling)
