## CONDITION REPORT

Report No:  
2017304546  
DATE  
29/09/2026

| Manufacturer | SUZUKI | Registration Number | MK08CGGP |
| Model | ERTIGA 1.5 GA MPV [2022-2025] | Register Number | |

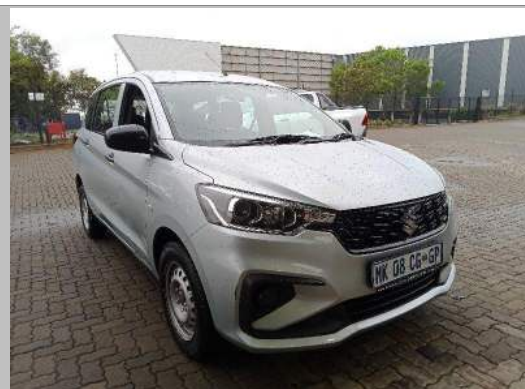
FRONT RIGHT CORNER

| Headlight Right Damaged | Replace |
| Front Bumper Paintwork • Scratched | Repair |
| A • Pillar Right Damaged | Repair |
| Door Front Right Damaged | Repair |
| Door Rear Right Dented | Repair |
| Sill Panel Right Damaged | Repair |

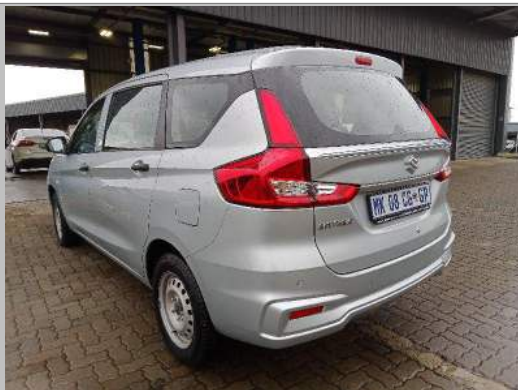
REAR LEFT CORNER

| Door Rear Left Damaged | Repair |
| Rim Rear Left Dented | Repair |

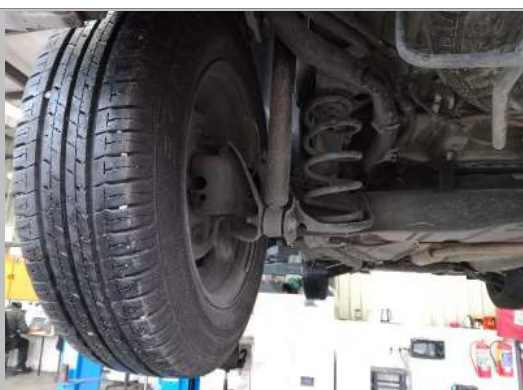
LR TYRE TREAD

| | Size | Load/Speed Index | Manufacture | Model | Type* | Production Date | Tread Depth (mm) |
|---|---|---|---|---|---|---|---|
| Rear Left | 185/65 R15 | 88H | Bridgestone | Ecopia | V | 1325 | 5 mm |

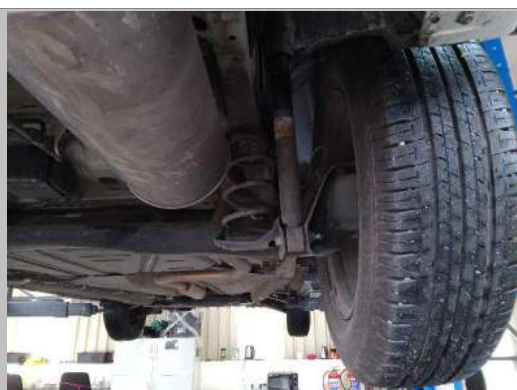
RR TYRE TREAD

| | Size | Load/Speed Index | Manufacture | Model | Type* | Production Date | Tread Depth (mm) |
|---|---|---|---|---|---|---|---|
| Rear Right | 185/65 R15 | 88H | Bridgestone | Ecopia | V | 1325 | 5 mm |

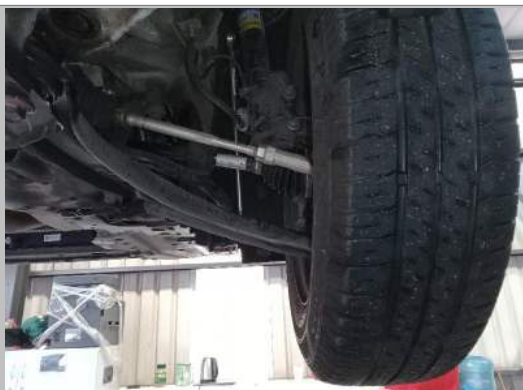
RF TYRE TREAD

| | Size | Load/Speed Index | Manufacture | Model | Type* | Production Date | Tread Depth (mm) |
|---|---|---|---|---|---|---|---|
| Front Right | 185/65 R15 | 88H | Bridgestone | Ecopia | V | 1325 | 4 mm |
