## CONDITION REPORT

Report No:  
2017295717  
DATE  
08/09/2026

| Manufacturer | SUZUKI | Registration Number | DD06XDZN |
| Model | ERTIGA 1.5 GA MPV [2022-2025] | Register Number | |

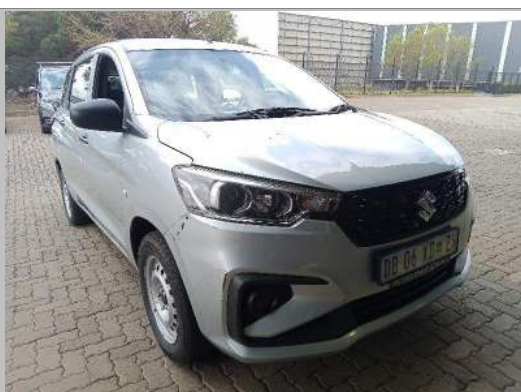
FRONT RIGHT CORNER

| Indicator Light Front Right Damaged | Replace |
| Front Fender Right Damaged | Repair |

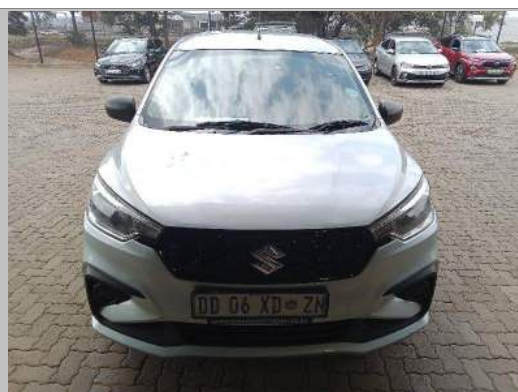
90 DEGREE FRONT

| Headlight Left Damaged | Replace |
| Headlight Right Scratched | Replace |
| Front Bumper Paintwork • Scratched | Repair |
| Bonnet Damaged | Repair |

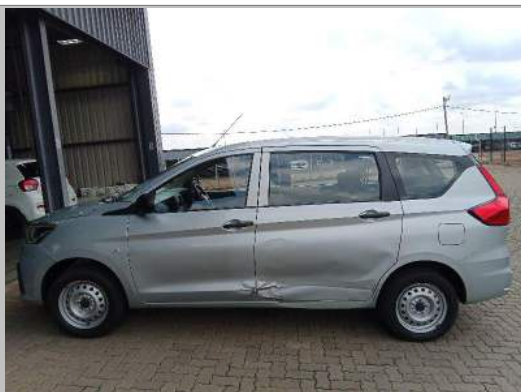
90 DEGREE LEFT

| A • Pillar Left Damaged | Repair |
| Door Front Left Damaged | Repair |
| Door Rear Left Damaged | Repair |
| Sill Panel Left Damaged | Repair |

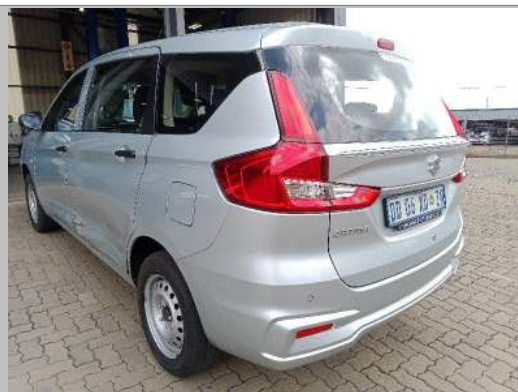
REAR LEFT CORNER

| Rear Fender Left Damaged | Repair |
| Rim Rear Left Dented | Repair |

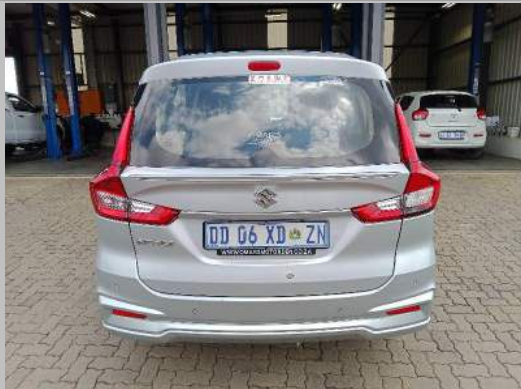
90 DEGREE REAR

| Tail Light Right Damaged | Replace |

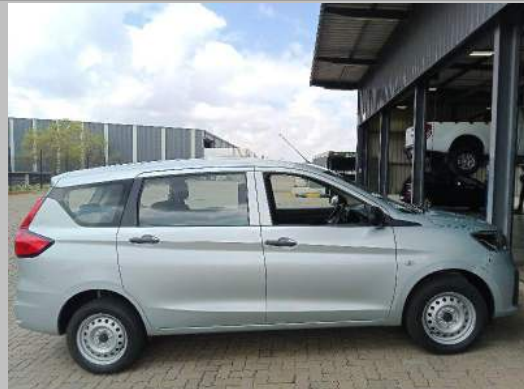
90 DEGREE RIGHT

| C • Pillar Right Paintwork • Scratched | Repair |
| Rear Fender Right Paintwork • Scratched | Repair |
| Door Front Right Paintwork • Scratched | Repair |
| Door Rear Right Paintwork • Scratched | Repair |

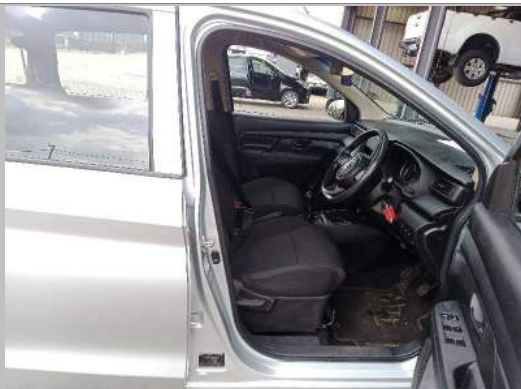
INTERIOR (FRONT DRIVER DOOR)

General Comments: ACCORDING TO THE AGE AND MILEAGE OF THE VEHICLE, NORMAL WEAR AND TEAR MARKS ARE VISIBLE ON THE EXTERIOR AND INTERIOR ELECTRICAL AND MECHANICAL PARTS. Interior: Vehicle interior dirty and panels scratched. Rear left and right storage lids missing.  
Body • Exterior: Poor residual traces of repair on body panels. Body panels misaligned. Stone chips and spray work on body panels. Dents and scratches on body panels. Front left window does not close properly  
Undercarriage: Vehicle undercarriage dirty

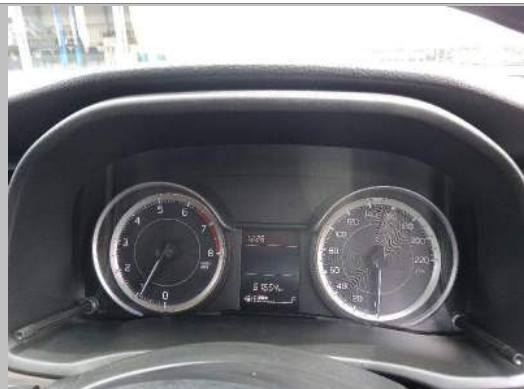
DASHBOARD (W/ ENGINE RUNNING)

| No | System | Code | Description | Status |
|---|---|---|---|---|
| 1 | ABS/ESP(ANTI-LOCK BRAKING SYSTEM/ELECTRONIC STABIL | C1057 | POWER SUPPLY VOLTAGE | |

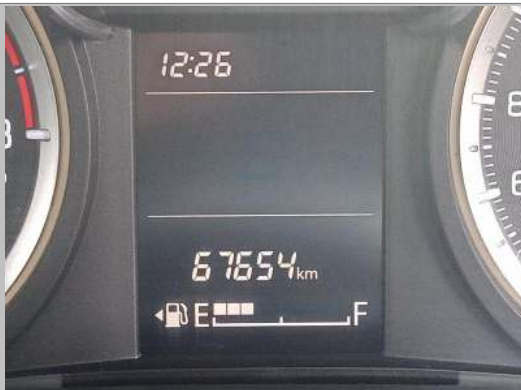
ODOMETER

| Km Reading | 67,654 KM | Fuel | PETROL |

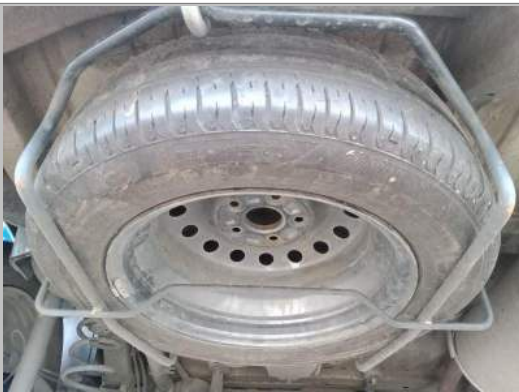
Spare Wheel

| | Size | Load/Speed Index | Manufacture | Model | Type* | Production Date | Tread Depth (mm) |
|---|---|---|---|---|---|---|---|
| Spare | 185/65 R15 | 88H | Bridgestone | Ecopia | V | | 2 mm |

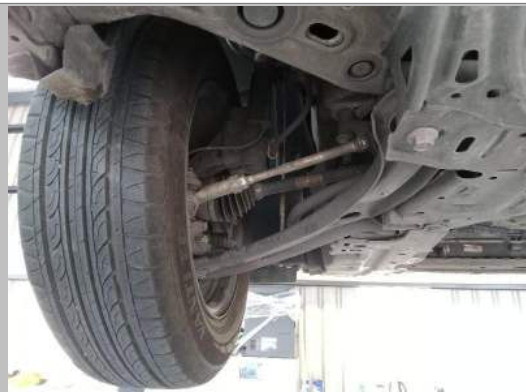
LF TYRE TREAD

| | Size | Load/Speed Index | Manufacture | Model | Type* | Production Date | Tread Depth (mm) |
|---|---|---|---|---|---|---|---|
| Front Left | 185/65 R15 | 88H | Centara | Touring | V | 1426 | 4 mm |

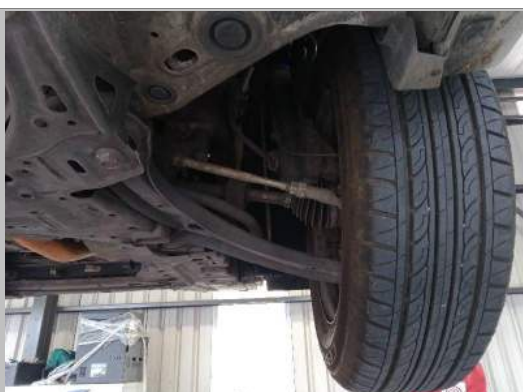
RF TYRE TREAD

| | Size | Load/Speed Index | Manufacture | Model | Type* | Production Date | Tread Depth (mm) |
|---|---|---|---|---|---|---|---|
| Front Right | 185/65 R15 | 88H | Centara | Touring | V | 1326 | 4 mm |
