MFC Auction House
M57 Pretoria Rd, Glenmarais, KEMPTON PARK
Gauteng

DEKRA MFC
M57 Pretoria Rd - 1619
KEMPTON PARK - GT
08610 33572

Vehicle Type	PASSENGER VEHICLE	Registered Owner	
Manufacturer	SUZUKI	Registration Number	NONE
Model	S-PRESSO 1.0 GL+ [2020-2022]	Register Number	
VIN	MA3RFL41S00372834	Date Of First Licensing	
Engine Number		Last COR	
Doors	5	License Expiry Date	
Color	GREY	Power / Displacement	
Year Model	2022	Paint Finish	TWO COAT UNI
Km Reading	144,899 KM	Fuel	PETROL
Cab / Body Type	HATCHBACK	Transmission	MANUAL

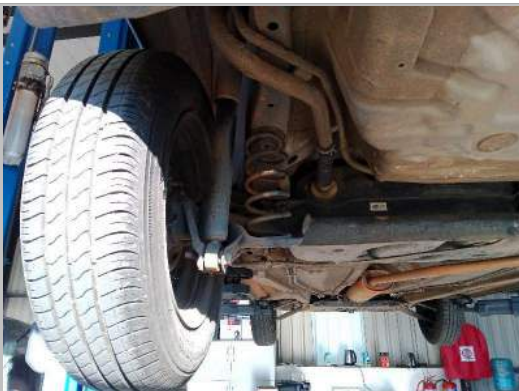
RF TYRE TREAD

Size	Load/Speed Index	Manufacture	Model	Type*	Production Date	Tread Depth (mm)
Front Left	165/70 R14	81S	MRF	ZVTV	V	1722	2 mm
Front Right	165/70 R14	81T	Ceat	Ecodrive	V	2023	5 mm
Rear Left	165/70 R14	81S	MRF	Ecotred	V	1722	5 mm
Rear Right	165/70 R14	81S	MRF	ZVTV	V	1723	4 mm

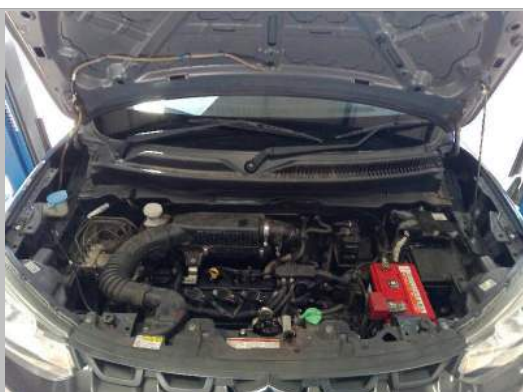
ENGINE 1

Damage	Repair Way
Engine Oil Leak	Repair
Air Conditioner Insufficient	Replace
Seat Front Left Damaged	Repair
Seat Front Right Damaged	Repair
Seat Rear Damaged	Repair
Door Lock Front Right Damaged	Replace
Boot Carpet Damaged	Repair
Mirror Adjusters Damaged	Replace
Steering Wheel Trim Defective	Repair
Side Mirror Left Paintwork • Scratched	Repair
Side Mirror Right Paintwork • Scratched	Repair
Front Bumper Damaged	Repair
Bonnet Paintwork • Chipmarks	Repair
B • Pillar Right Dented	Repair
Front Fender Left Dented	Repair
Front Fender Right Paintwork • Scratched	Repair
Rear Fender Left Dented	Repair
Rear Fender Right Dented	Repair
Door Front Left Damaged	Repair
Door Front Right Paintwork • Scratched	Repair
