CONDITION REPORT

Report No: 2016835778

DATE
09/04/2025

Vehicle Type	PASSENGER VEHICLE	Registered Owner	
Manufacturer	FORD	Registration Number	BG43TWGP
Model	FIGO 1.4 TREND 5-DR [2010-2012]	Register Number	
VIN	MAJ1XXMRJ1BC02552	Date Of First Licensing	
Engine Number		Last COR	
Doors	5	License Expiry Date	31/03/2024
Color	BLUE	Power / Displacement	
Year Model	2011	Paint Finish	C - COMMON
Km Reading	338,171 KM	Fuel	PETROL
Cab / Body Type	HATCHBACK	Transmission	MANUAL

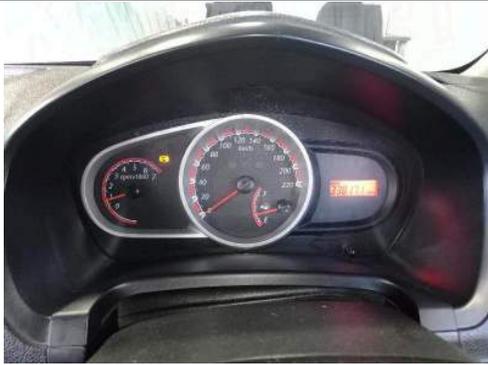
DASHBOARD (W/ ENGINE RUNNING)

Loose wires in the boot	Repair
L/F fender liner damage	Replace
Water leak	Vehicle got water leak can't pin point water leak
ABS light on	Repair
Bonnet not closing properly	Repair
Both front fog lights malfunction	Repair
Front suspension noisy	Repair
Airbag light on	Repair

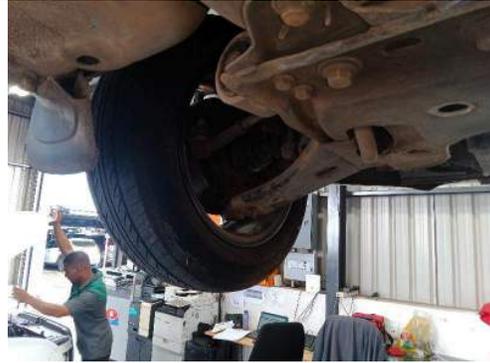
LF TYRE TREAD

Size	Load/Speed Index	Manufacture	Model	Type*	Production Date	Tread Depth (mm)
Front Left	175/65R14	86T	Roadshine	Rs906	V	1628	2 mm
Front Right	175/65R14	86T	Roadshine	Rs906	V	1723	3 mm
Rear Left	175/65R14	82H	Rapid	P309	V	1419	0 mm
Rear Right	175/65R14	86T	Roadshine	Rs906	V	1623	4 mm

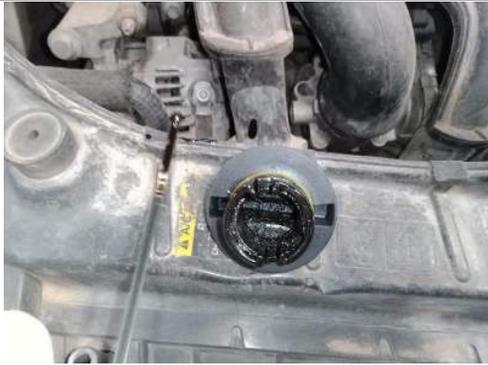
Oil cap and dipstick

Damage	Repair Way
Engine Oil Leak	Repair
Caps Missing	Repair
Water level Insufficient	Repair
Air conditioner pipes Damaged	Repair
Center Console / Cubbyhole + Lid Damaged	Repair
Indicator Light Front Left Damaged	Replace
Indicator Light Front Right Damaged	Replace
Tail Light Left Damaged	Replace
Tail Light Right Cracked	Repair
Interior Mirror Missing	Replace
Side Mirror Left Paintwork • Scratched	Repair
Rear Upper Valance Welded	Repair
Front Bumper Paintwork • Scratched	Repair
Bonnet Paintwork • Scratched	Repair
Front Fender Left Paintwork • Scratched	Repair
Front Fender Right Paintwork • Scratched	Repair
Rear Fender Left Residual Traces of Repair	Repair
Rear Fender Right Dented	Repair
Door Front Left Dented	Repair
Door Front Right Paintwork • Scratched	Repair

Damage	Repair Way
Door Rear Left Paintwork • Scratched	Repair
Door Rear Right Paintwork • Scratched	Repair
Boot Lid / Hatch door Residual Traces of Repair	Repair
Rear bumper Residual Traces of Repair	Repair
Inner Boot Floor Pan and Spare Wheel Well Residual Traces of Repair	Repair
Sill Panel Left Dented	Repair
Sill Panel Right Dented	Repair
Steering Rack Boot Right Damaged	Replace
Tyre Rear Left Smooth	Replace
Bolt(s) / Nut(s) Front Wheel Left Missing	Replace
Bolt(s) / Nut(s) Front Wheel Right Missing	Replace
CV Joint(s) Boot(s) Front Left (inner/outer) Damaged	Replace
CV Joint(s) Boot(s) Front Right (inner/outer) Loose / Excessive Play	Repair
Gear Selections Insufficient	Repair
Body exterior	Vehicle got some scratches, stone chips and dents
Body exterior	Signs of spray work done on some body panels
Body exterior	Signs of repair work done on some body panels
Dipstick damage	Replace
L/F kick panel loose	Repair
