## CONDITION REPORT

Report No: 2016337596

MFC Auction House  
M57 Pretoria Rd, Glenmarais, KEMPTON PARK  
Gauteng

Vehicle Type	PASSENGER VEHICLE	Registered Owner	MFC AUCTION HOUSE
Manufacturer	FORD	Registration Number	DW22ZLGP
Model	IKON	Register Number	
VIN	MAJBXXMRTBFE28629	Date Of First Licensing	
Engine Number		Last COR	
Doors	4	License Expiry Date	31/03/2024
Color	WHITE	Power / Displacement	
Year Model		Paint Finish	TWO COAT UNI
Km Reading	291,972 KM	Fuel	PETROL
Cab / Body Type	SEDAN	Transmission	MANUAL

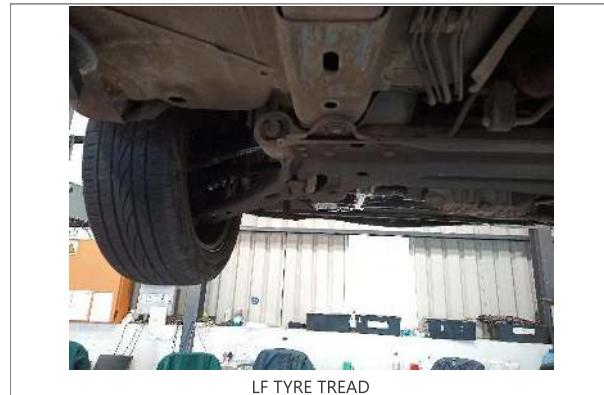
LF TYRE TREAD

Size	Load/Speed Index	Manufacture	Model	Type*	Production Date	Tread Depth (mm)
Front Left	195/55R15	85V	Sumitomo	Radial	V	1321	2 mm
Front Right	195/55R15	85V	Sumitomo	Radial	V	1321	2 mm
Rear Left	195/55R15	82V	Sumitomo	Radial	V	1321	2 mm
Rear Right	195/55R15	85H	Goodyear	Eagle	V	1215	0 mm
