## CONDITION REPORT

Report No:  
2016998456  
DATE  
01/09/2025

| Manufacturer | FORD | Registration Number | KPY501NW |
| VIN | MAJGXXMTKGMA00820 | Date Of First Licensing | |

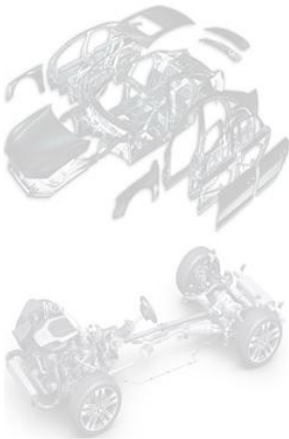
| | Damage | Repair Way |
|---|---|---|
| | Rear Fender Left Paintwork • Scratched | Repair |
| | Door Front Left Paintwork • Scratched | Repair |
| | Door Rear Left Paintwork • Scratched | Repair |
| | Rear bumper Paintwork • Scratched | Repair |
