CONDITION REPORT

Report No: 2016395930

MFC Auction House
M57 Pretoria Rd, Glenmarais, KEMPTON PARK
Gauteng

Vehicle Type	PASSENGER VEHICLE	Registered Owner	MFC AUCTION HOUSE
Manufacturer	HONDA	Registration Number	JK67XNGP
Model	MAZE	Register Number	
VIN	MAKDF5630K4000339	Date Of First Licensing	
Engine Number		Last COR	
Doors	4	License Expiry Date	31/01/2024
Color	WHITE	Power / Displacement	
Year Model		Paint Finish	M - METALLIC
Km Reading	191,533 KM	Fuel	PETROL
Cab / Body Type	SEDAN	Transmission	AUTOMATIC

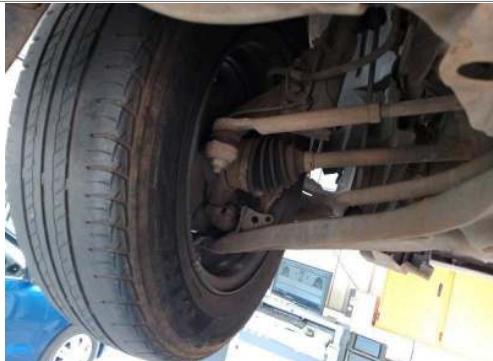
LF TYRE TREAD

Size	Load/Speed Index	Manufacture	Model	Type*	Production Date	Tread Depth (mm)
Front Left	175/70R14	84T	MRF	ZVT	V	2919	1 mm
Front Right	185/65R15	88H	Nexen	Nblue	V	3618	3 mm
Rear Left	175/65R15	84H	Firestone	Touring	V	3516	1 mm
Rear Right	185/60R15	84H	Rapid	P309	V	3019	1 mm
Spare	185/65R15	92T	Barum	Brillantis	V	//////	0 mm

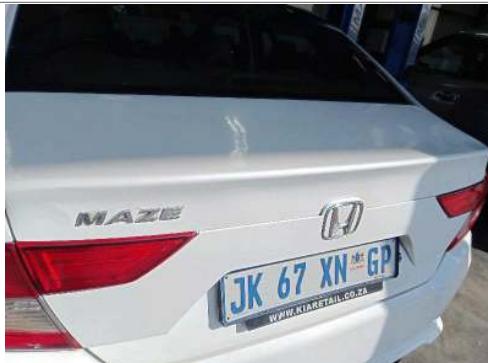
Door Rear Left Residual Traces of Repair	Repair
Door Rear Right Residual Traces of Repair	Repair
Boot Lid / Hatch door Residual Traces of Repair	Repair
Rear bumper Damaged	Repair

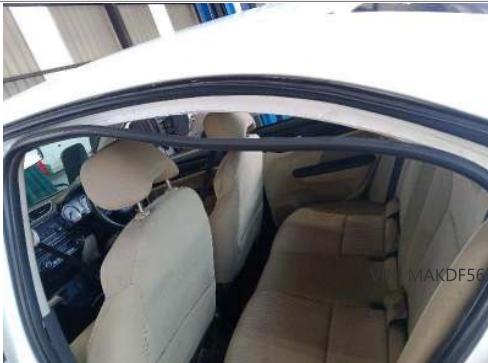
Damage	Repair Way
Engine Wiring Defective	Repair
Battery clamps Defective	Repair
Air conditioner pipes Defective	Repair
Bonnet hinges Damaged	Replace
Windscreen Wiper Worn	Replace
Tail Light Left Cracked	Replace
Headlight Right Chipped	Replace
Seat Front Right Torn / Cut	Repair
Door Sealing Rubber Rear Left Damaged	Replace
Door Sealing Rubber Rear Right Damaged	Replace
Side Mirror Left Damaged	Replace
Side Mirror Right Damaged	Replace
Front Bumper Damaged	Replace
Grill Damaged	Replace
Bonnet Residual Traces of Repair	Repair
Bonnet slam plate (Shock tower/ Inner tray) Residual Traces of Repair	Repair
C • Pillar Left Welded	Replace
Front Fender Left Residual Traces of Repair	Repair
Front Fender Right Residual Traces of Repair	Replace
Rear Fender Left Residual Traces of Repair	Repair
Rear Fender Right Damaged	Repair
Rear Fender Left / Inner Tray Damaged	Repair
Door Front Left Residual Traces of Repair	Repair
Door Front Right Residual Traces of Repair	Repair

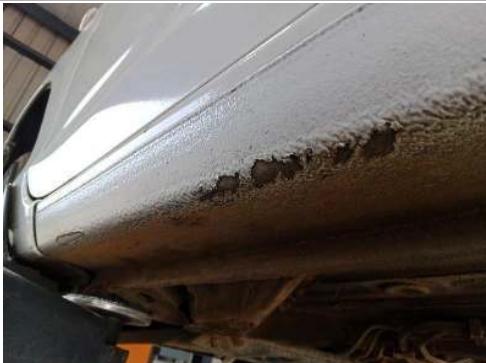
Damage	Repair Way
Sill Panel Left Residual Traces of Repair	Repair
Roof Residual Traces of Repair	Repair
Windscreen Cracked	Replace
Rear Axle Damaged	Replace
Tyre Front Right Excessive Wear & Tear	Replace
Tyre Rear Left Excessive Wear & Tear	Replace
Tyre Rear Right Excessive Wear & Tear	Replace
Spare Tyre Excessive Wear & Tear	Replace
Main Beam Left Welded	Replace
Catalytic converter Welded	Replace
Radiator Cradle Welded	Replace
Body exterior	Sparewheel damage
Body exterior	Signs of spray work done on all body panels
Electronics malfunction	Both front electric mirrors malfunction.
Residual traces of welding on chassis leg extensio	radiator cradle signs of welding.
Axle and suspension	Both front control arm bushes covered
Signs of welding on some body panels	Repair
