MFC Auction House  
M57 Pretoria Rd, Glenmarais, KEMPTON PARK  
Gauteng

Vehicle Type	PASSENGER VEHICLE	Registered Owner	MFC
Manufacturer	HYUNDAI	Registration Number	KD13JNGP
Model	ATOS	Register Number	
VIN	MALAF51CLNM151166	Date Of First Licensing	
Engine Number		Last COR	
Doors	5	License Expiry Date	31/07/2023
Color	SILVER	Power / Displacement	
Year Model		Paint Finish	M - METALLIC
Km Reading	32,959 KM	Fuel	PETROL
Cab / Body Type	HATCHBACK	Transmission	MANUAL

### VEHICLE INSPECTION

Report No: 2016209356

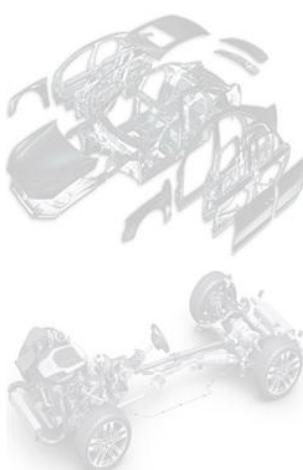
Damage	Repair Way
Indicator Light Front Left Missing	Replace
Headlight Right Damaged	Repair
Seat Front Right Torn / Cut	Repair
Front Bumper Paintwork • Scratched	Repair
Bonnet slam plate (Shock tower/ Inner tray) Corrosion	Repair
A • Pillar Right Dented	Repair
Front Fender Left Residual Traces of Repair	Replace
Front Fender Right Residual Traces of Repair	Replace
Rear Fender Right Paintwork • Scratched	Repair
Door Front Left Dented	Repair
Boot Lid / Hatch door Dented	Repair
Rear bumper Paintwork • Scratched	Repair
Fuel Flap Damaged	Replace
Sill Panel Left Dented	Repair
Windscreen Chipped	Repair
Window Rear Door Right Damaged	Replace
Shock Absorber Rear Left Leak	Replace
Spare Tyre Damaged	Replace
Radiator Cradle Damaged	Repair
Battery loose	Repair
R/F fender line missing	Replace
