CONDITION REPORT

Report No: 2016467642

MFC Auction House
M57 Pretoria Rd, Glenmarais, KEMPTON PARK
Gauteng

Vehicle Type	PASSENGER VEHICLE	Registered Owner	
Manufacturer	HYUNDAI	Registration Number	KR24RKGP
Model	ATOS	Register Number	
VIN	MALAF51CLNM181544	Date Of First Licensing	
Engine Number		Last COR	
Doors	5	License Expiry Date	30/06/2023
Color	SILVER	Power / Displacement	
Year Model		Paint Finish	M - METALLIC
Km Reading	27,251 KM	Fuel	PETROL
Cab / Body Type	HATCHBACK	Transmission	MANUAL

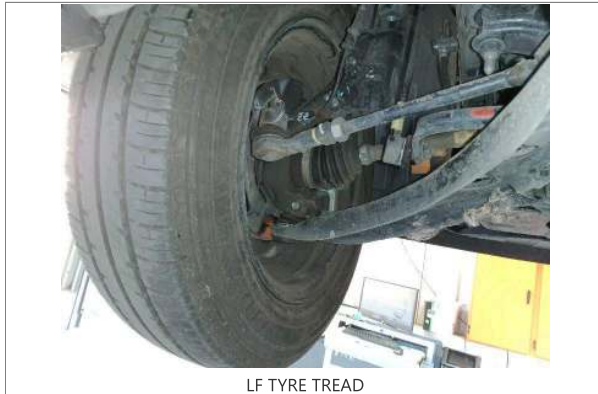
LF TYRE TREAD

Size	Load/Speed Index	Manufacture	Model	Type*	Production Date	Tread Depth (mm)
Front Left	165/70R14	81T	MRF	ZVTV	V	0000	5 mm
Front Right	165/70R14	81T	MRF	ZVTV	V	0000	3 mm
Rear Left	175/70R14	81T	MRF	ZVTV	V	0000	5 mm
Rear Right	165/70R14	81T	MRF	ZVTV	V	0000	5 mm
Spare	155/80R13	79T	MRF	ZVTV	V	0000	6 mm
