## CONDITION REPORT

Report No:  
2016962855  
DATE  
30/07/2025

| Manufacturer | HYUNDAI | Registration Number | BT89BSGP |
| Model | I20 1.4 GL 5-DR [2009-2013] | Register Number | |

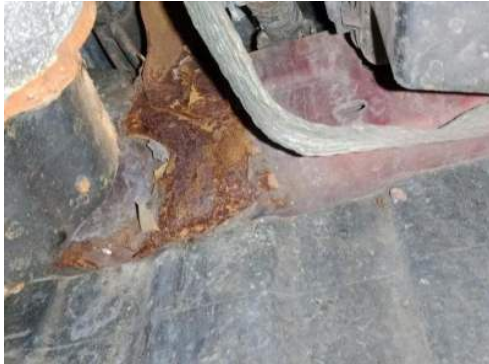
| Damage | Repair Way |
|---|---|
| Main Beam Left Damaged | Repair |
