CONDITION REPORT

Report No:  
2017305240  
DATE  
30/09/2026

MFC Auction House  
M57 Pretoria Rd, Glenmarais, KEMPTON PARK  
Gauteng

| Manufacturer | HYUNDAI | Registration Number | BC99KHGP |

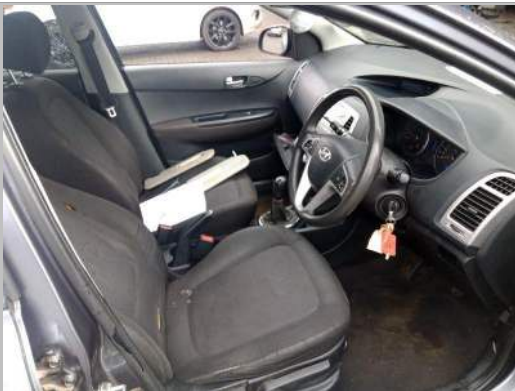
INTERIOR (FRONT DRIVER DOOR)

| Driver side door does not open from outside | Repair |
| Driver's door electric window does not work. | Repair |

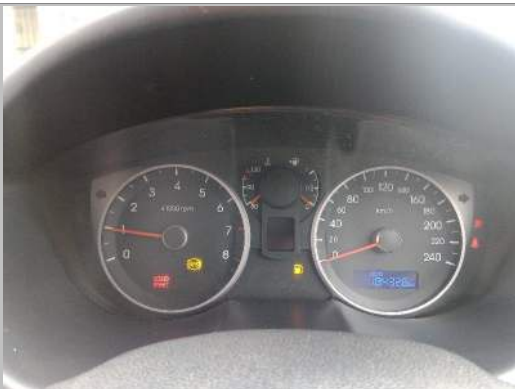
DASHBOARD (W/ ENGINE RUNNING)

| Engine Management Lights Set | Repair |

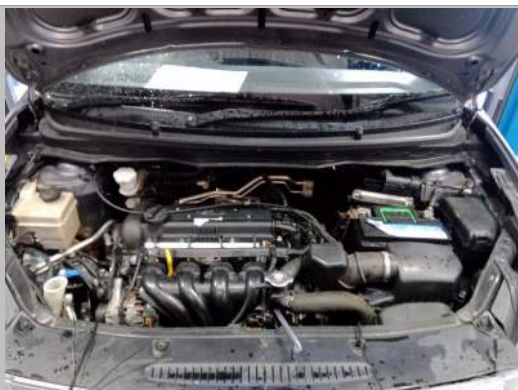
ENGINE 1

| Engine Oil Leak | Repair |

General Comments: ACCORDING TO THE AGE AND MILEAGE OF THE VEHICLE, NORMAL WEAR AND TEAR MARKS ARE VISIBLE ON THE INTERIOR, EXTERIOR, ELECTRICAL AND MECHANICAL PARTS. SIGNS OF REPAIR WORK DONE TO BODY PANELS. POOR ALIGNMENT TO SOMEBODY PANELS. REPAIR WORK DONE TO VEHICLE BELOW STANDARD / FOREIGN SUBSTANCE ON OIL FILLER CAP.
