CONDITION REPORT

Report No:  
2017302333  
DATE  
22/09/2026

MFC Auction House  
M57 Pretoria Rd, Glenmarais, KEMPTON PARK  
Gauteng

| Manufacturer | HYUNDAI | Registration Number | KS31DFGP |

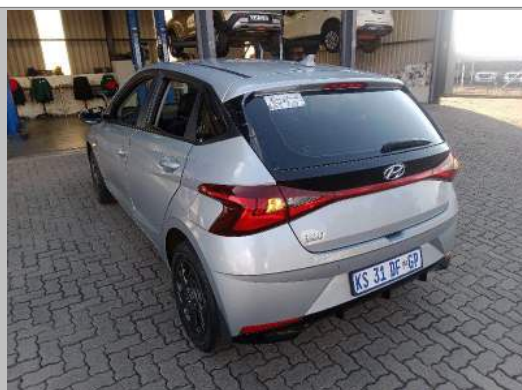
REAR LEFT CORNER

| Rear Fender Left Dented | Repair |

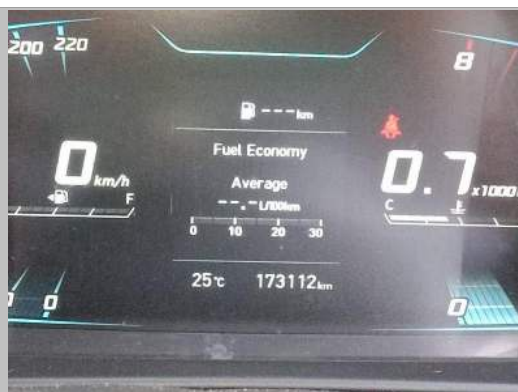
ODOMETER

| Km Reading | 173,112 KM | Fuel | PETROL |

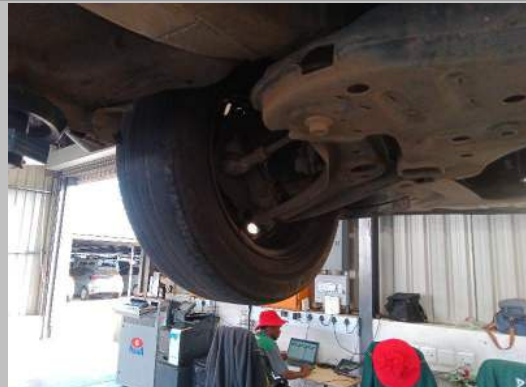
LF TYRE TREAD

| | Size | Load/Speed Index | Manufacture | Model | Type* | Production Date | Tread Depth (mm) |
|---|---|---|---|---|---|---|---|
| Front Left | 185/65R15 | 88H | Bridgestone | Ecopia | V | 1521 | 2 mm |

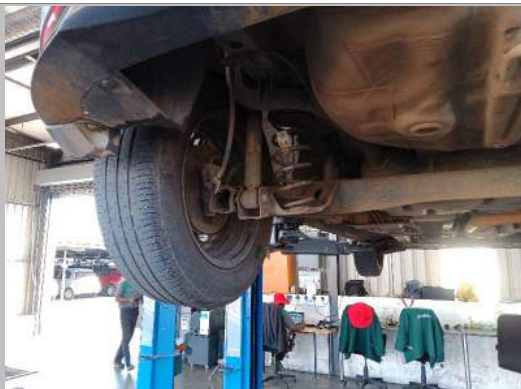
LR TYRE TREAD

| | Size | Load/Speed Index | Manufacture | Model | Type* | Production Date | Tread Depth (mm) |
|---|---|---|---|---|---|---|---|
| Rear Left | 185/65R15 | 88H | Bridgestone | Ecopia | V | 0622 | 3 mm |

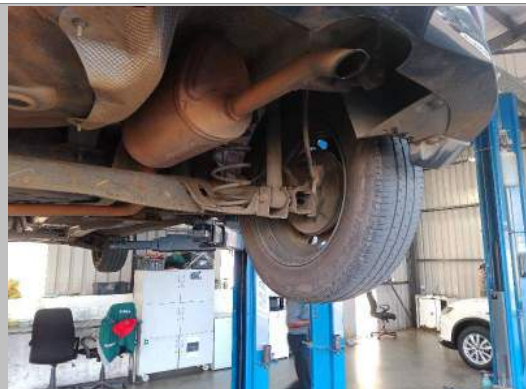
RR TYRE TREAD

| | Size | Load/Speed Index | Manufacture | Model | Type* | Production Date | Tread Depth (mm) |
|---|---|---|---|---|---|---|---|
| Rear Right | 185/65R15 | 88H | Bridgestone | Ecopia | V | 0622 | 3 mm |
