CONDITION REPORT

Report No:  
2017296486  
DATE  
09/09/2026

| Manufacturer | HYUNDAI | Registration Number | LF80PPGP |
| Model | I20 1.2 MOTION 5-DR [2021-2024] | Register Number | |

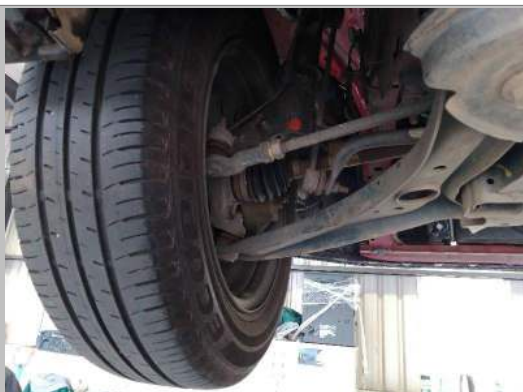
LF TYRE TREAD

| | Size | Load/Speed Index | Manufacture | Model | Type* | Production Date | Tread Depth (mm) |
|---|---|---|---|---|---|---|---|
| Front Left | 185/65 R15 | 88H | Bridgestone | Ecopia | V | 1925 | 4 mm |

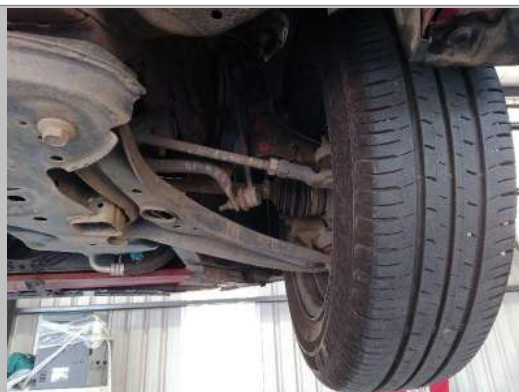
RF TYRE TREAD

| Tyre Front Right Damaged | Replace |

| | Size | Load/Speed Index | Manufacture | Model | Type* | Production Date | Tread Depth (mm) |
|---|---|---|---|---|---|---|---|
| Front Right | 185/65 R15 | 88H | Bridgestone | Ecopia | V | 1925 | 4 mm |

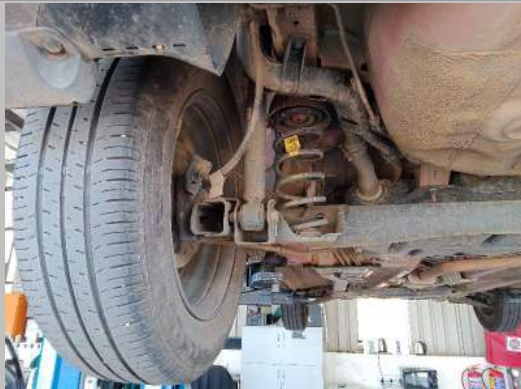
LR TYRE TREAD

| | Size | Load/Speed Index | Manufacture | Model | Type* | Production Date | Tread Depth (mm) |
|---|---|---|---|---|---|---|---|
| Rear Left | 185/65 R15 | 88H | Bridgestone | Ecopia | V | 0523 | 3 mm |

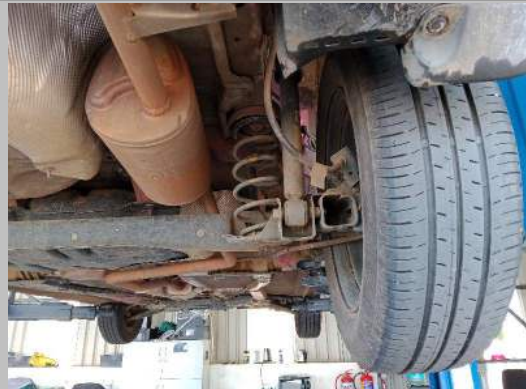
RR TYRE TREAD

| | Size | Load/Speed Index | Manufacture | Model | Type* | Production Date | Tread Depth (mm) |
|---|---|---|---|---|---|---|---|
| Rear Right | 185/65 R15 | 88H | Bridgestone | Ecopia | V | 1925 | 3 mm |
